**GEOTECHNICAL EVALUATION AND
ENVIRONMENTAL SOIL ASSESSMENT
LAS POSAS PROJECT
PALOMAR COLLEGE
SAN MARCOS, CALIFORNIA**

May 27, 2015
Project No. 106435019

Subject: Geotechnical Evaluation and Environmental Soil Assessment
Las Posas Project
Palomar College
San Marcos, California

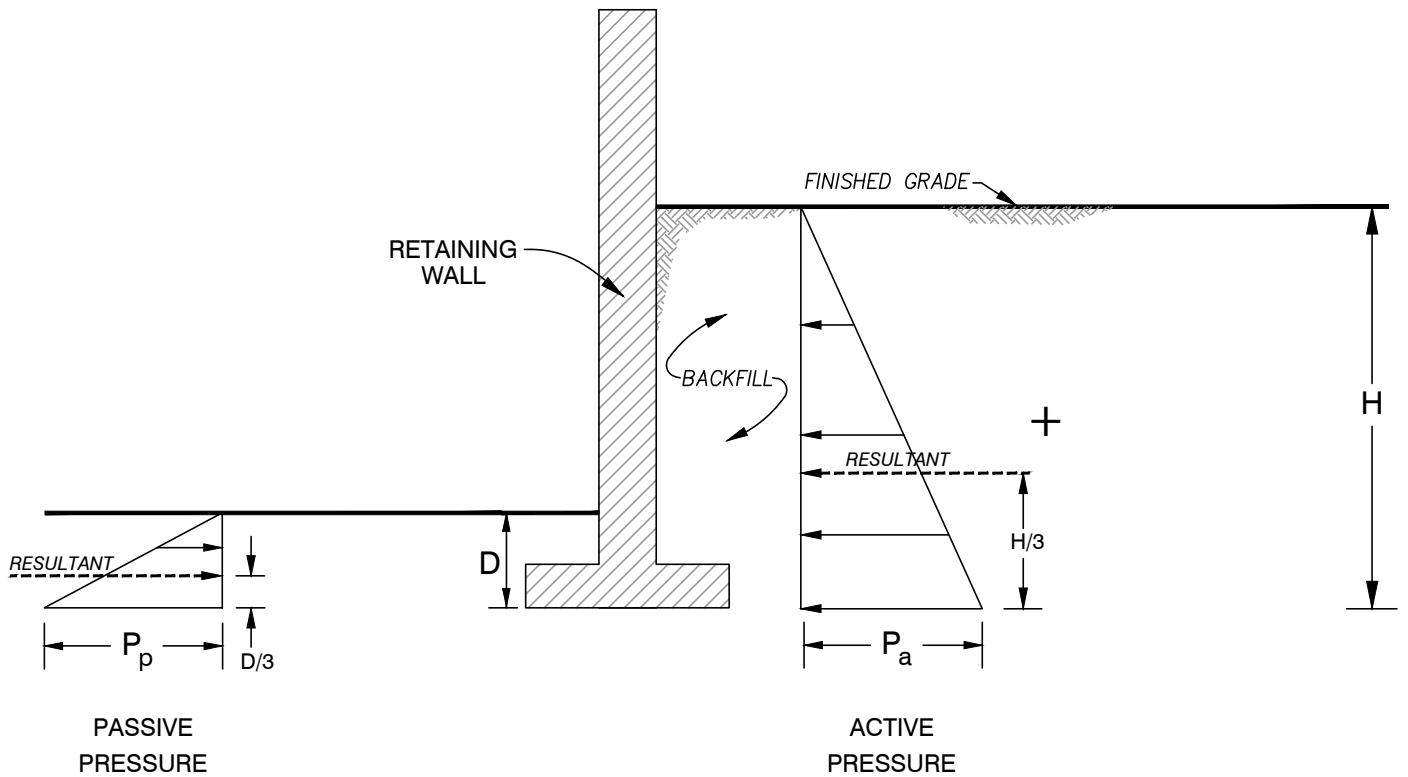
1. ASSUMES NO HYDROSTATIC PRESSURE BUILD-UP BEHIND THE RETAINING WALL
2. GRANULAR BACKFILL MATERIALS SHOULD BE USED FOR RETAINING WALL BACKFILL
3. DRAINS AS RECOMMENDED IN THE RETAINING WALL DRAINAGE DETAIL SHOULD BE INSTALLED BEHIND THE RETAINING WALL
4. SURCHARGE PRESSURES CAUSED BY VEHICLES OR NEARBY STRUCTURES ARE NOT INCLUDED
5. H AND D ARE IN FEET
6. SETBACK SHOULD BE IN ACCORDANCE WITH THE CBC (2013)

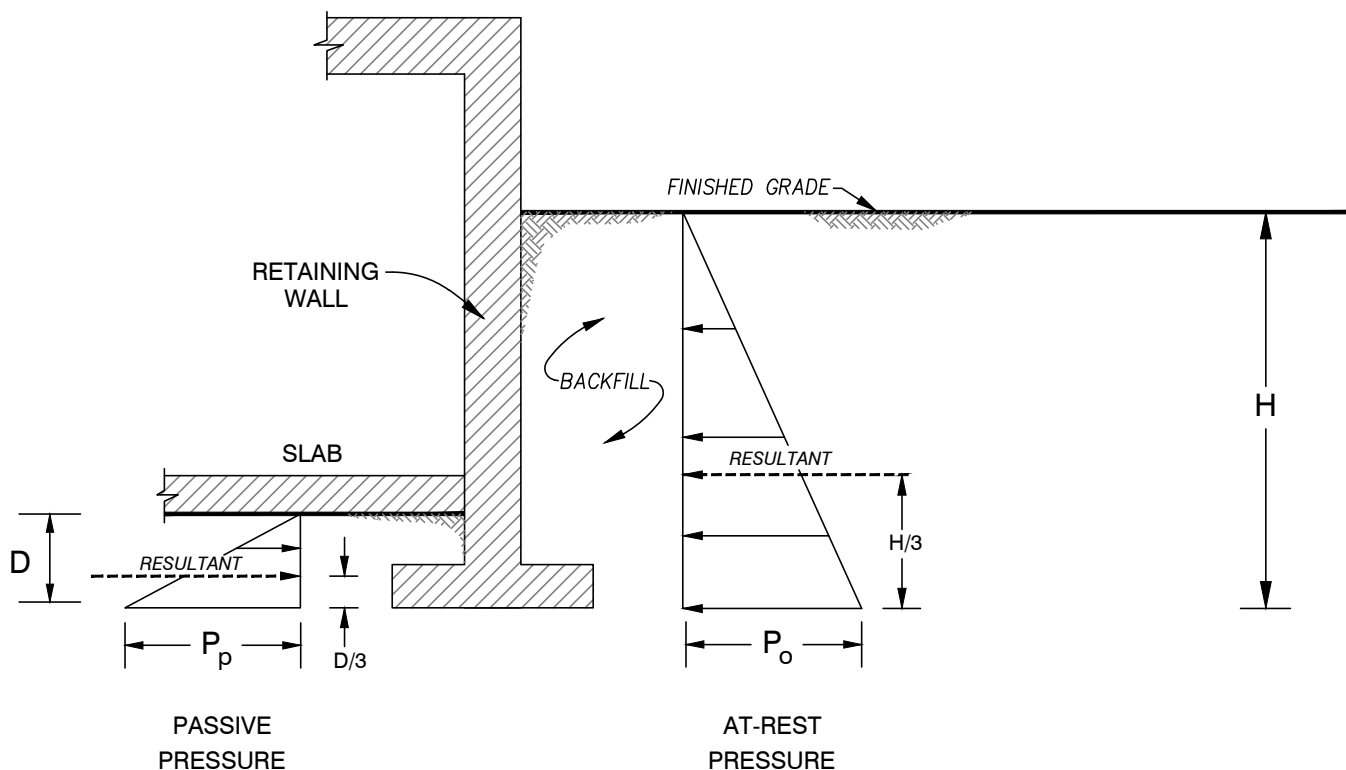
1. ASSUMES NO HYDROSTATIC PRESSURE BUILD-UP BEHIND THE RETAINING WALL
2. GRANULAR BACKFILL MATERIALS SHOULD BE USED FOR RETAINING WALL BACKFILL
3. DRAINS AS RECOMMENDED IN THE RETAINING WALL DRAINAGE DETAIL SHOULD BE INSTALLED BEHIND THE RETAINING WALL
4. SURCHARGE PRESSURES CAUSED BY VEHICLES OR NEARBY STRUCTURES ARE NOT INCLUDED
5. H AND D ARE IN FEET
