Snipes-Dye Associates
Palomar College Project
Subsurface Utility Report
July 19, 2018

Subsurface Utility Report

Customer	Snipes-Dye Associates
Project	Palomar College
Location	San Marcos, CA
Date	July 19, 2018

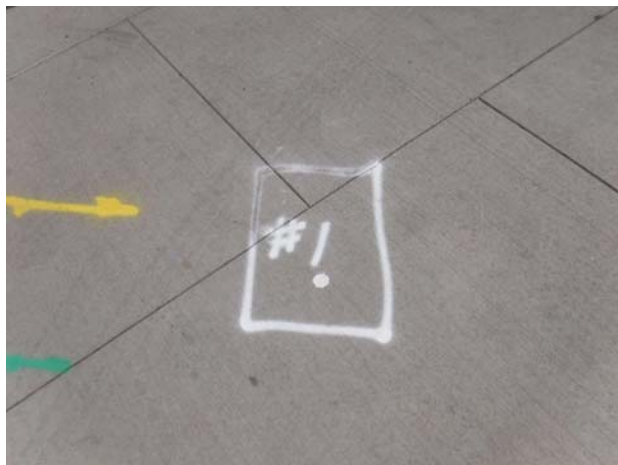
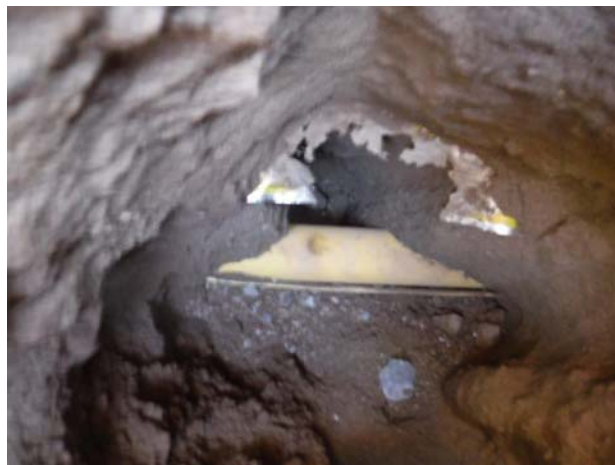
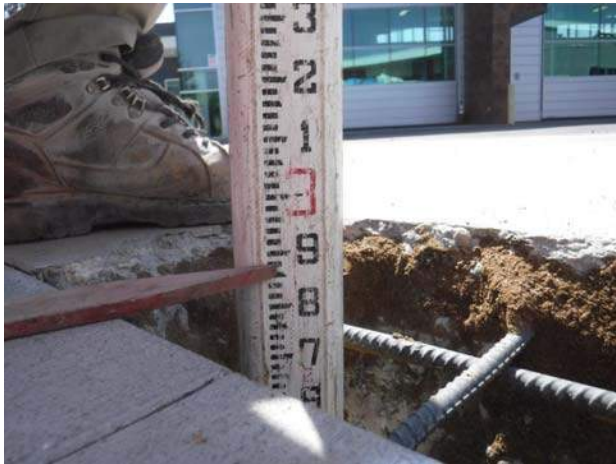
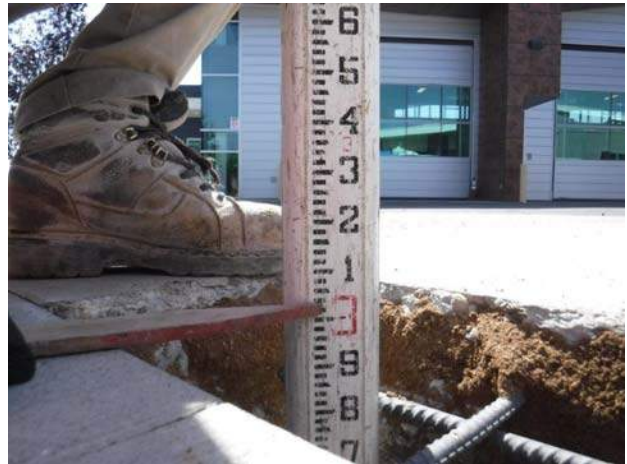
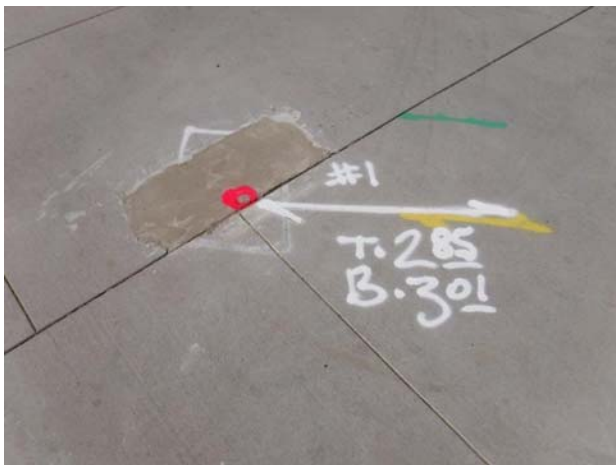
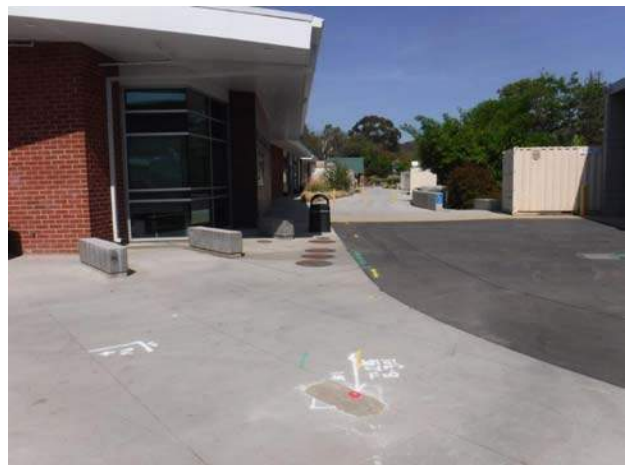
Pothole: 1

PH#	Station	Utility	Top (ft)	Bottom (ft)	Size	Type	Distance From Curb	Direction
1		G	2.85	3.01	1.5"	PE	22.20 ft from bldg	E/W

Comments					
Operator:	Munson, Tyler	Technician:	Iokia III, Samuel	Vehicle:	USI 6
Field Log #:	14022	Log Date:	07/16/2018	Soil Type:	Clay
Asphalt Depth:	0	Concrete Depth:	0.45	Marker:	PK Nail

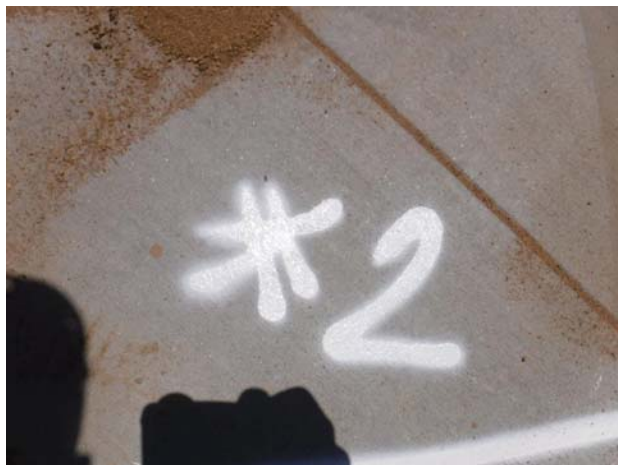
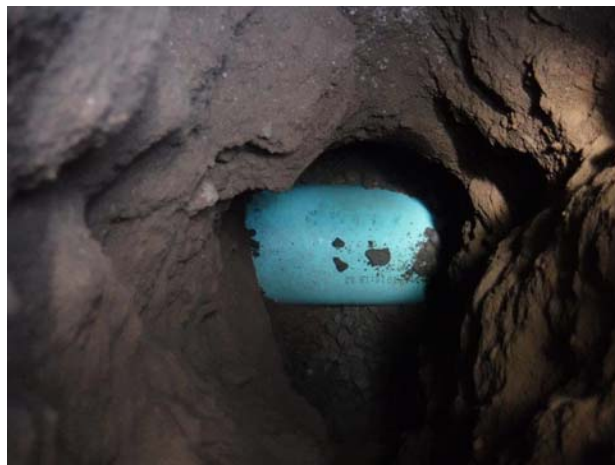
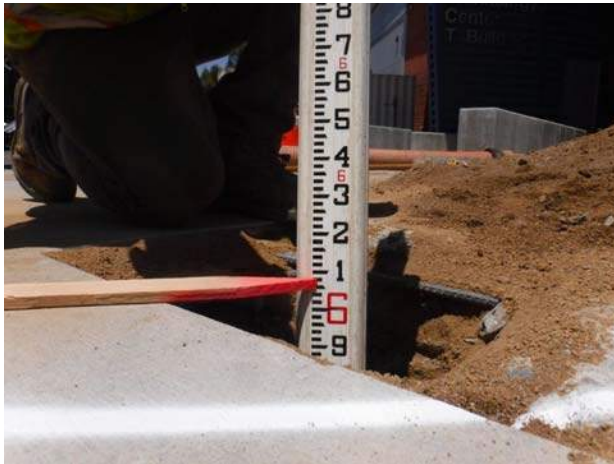
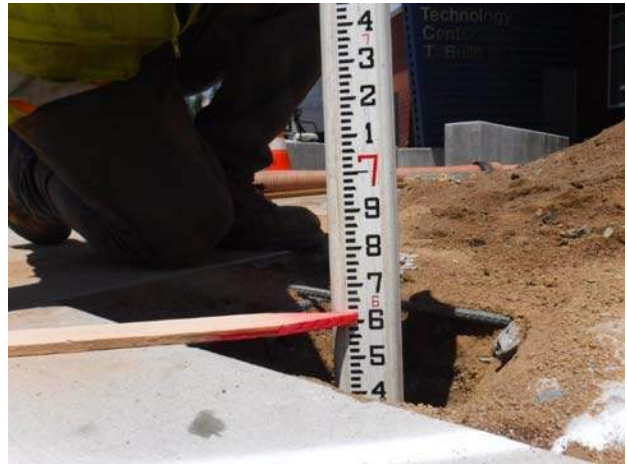
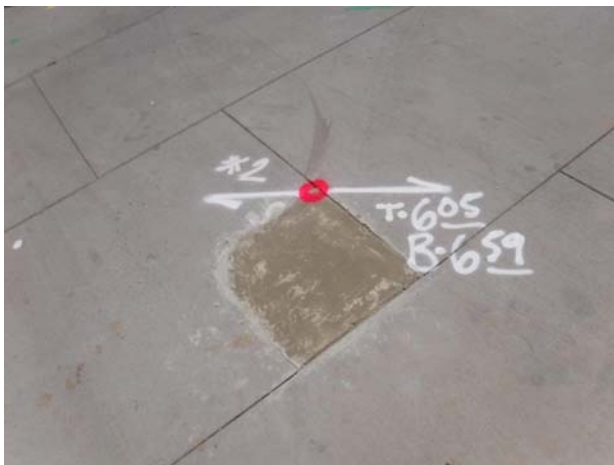
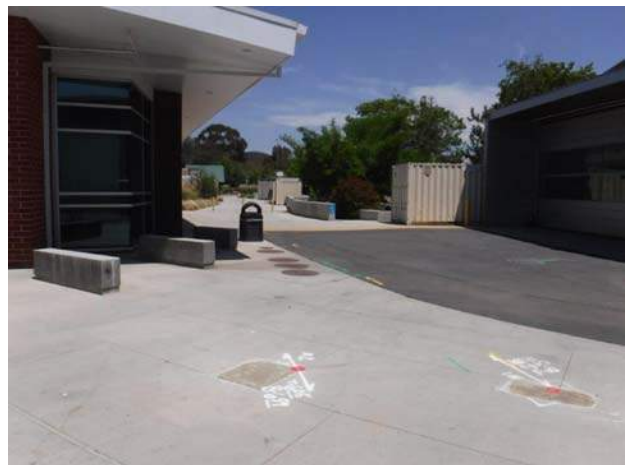
Pothole: 2

PH#	Station	Utility	Top (ft)	Bottom (ft)	Size	Type	Distance From Curb	Direction
2		SWR	6.05	6.59	6"	PVC	28.40 ft from corner of bldg	E/W

Comments					
Operator:	Munson, Tyler	Technician:	Iokia III, Samuel	Vehicle:	USI 6
Field Log #:	14028	Log Date:	07/17/2018	Soil Type:	Clay
Asphalt Depth:	0	Concrete Depth:	0.45	Marker:	PK Nail

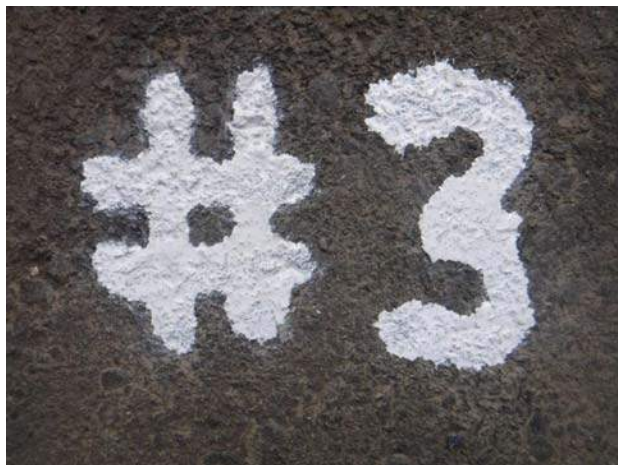
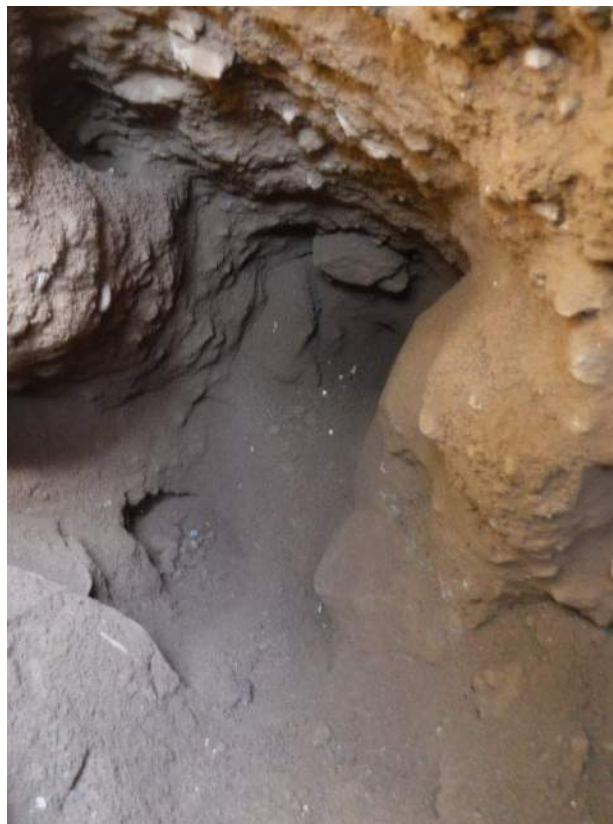
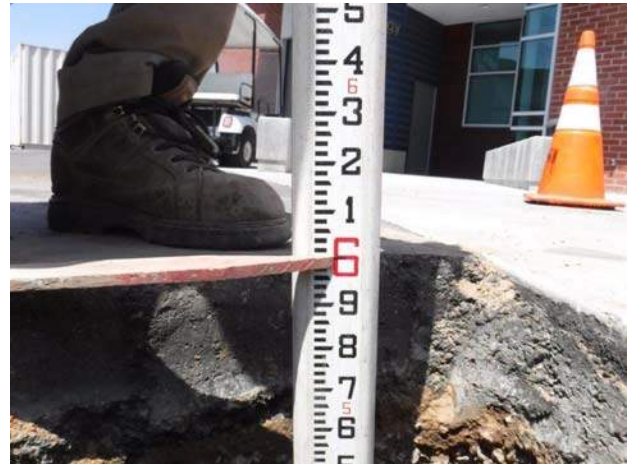
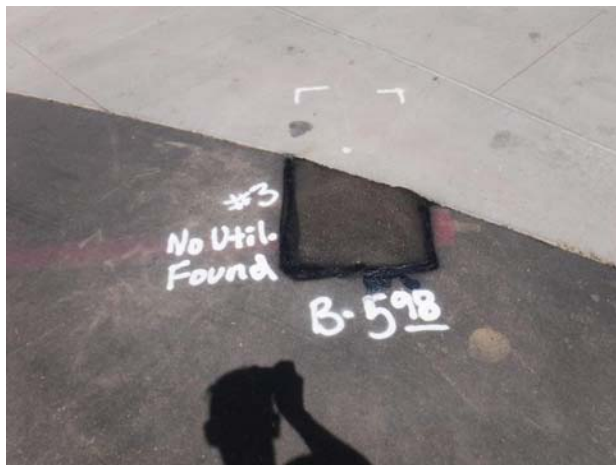
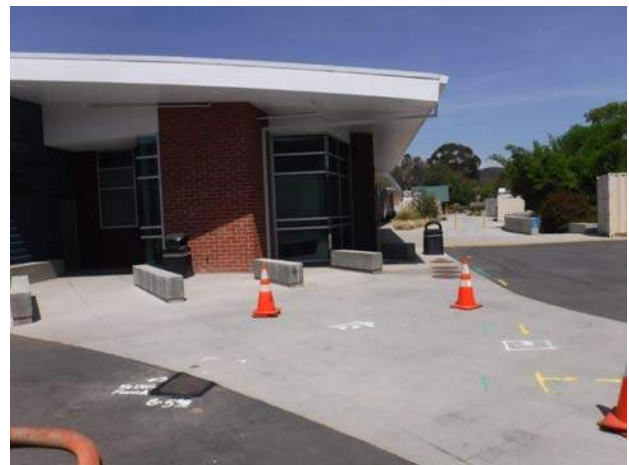
Pothole: 3

PH#	Station	Utility	Top (ft)	Bottom (ft)	Size	Type	Distance From Curb	Direction
3		Dry Hole	0.00	0.00		N/A		Unknown

Comments	No utility found to 5.98 ft. PH located 32.00 ft from bldg.				
Operator:	Munson, Tyler	Technician:	Iokia III, Samuel	Vehicle:	USI 6
Field Log #:	14021	Log Date:	07/16/2018	Soil Type:	Clay
Asphalt Depth:	0.35	Concrete Depth:	0.85 base	Marker:	Paint

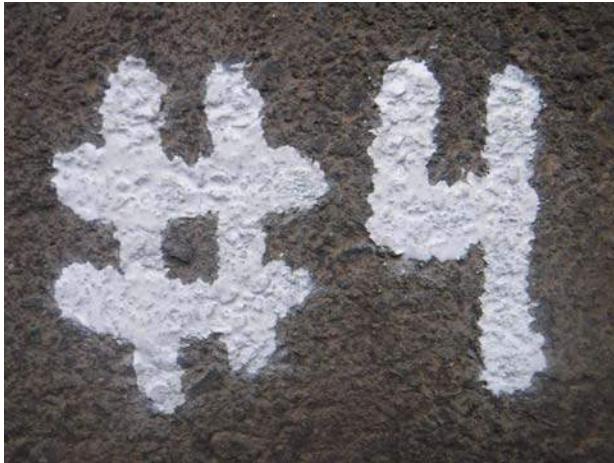
Pre-Excavation Photo

Comments					
Operator:	Munson, Tyler	Technician:	Iokia III, Samuel	Vehicle:	USI 6
Field Log #:	14028	Log Date:	07/17/2018	Soil Type:	Clay
Asphalt Depth:	0.50	Concrete Depth:	1.10 base	Marker:	PK Nail

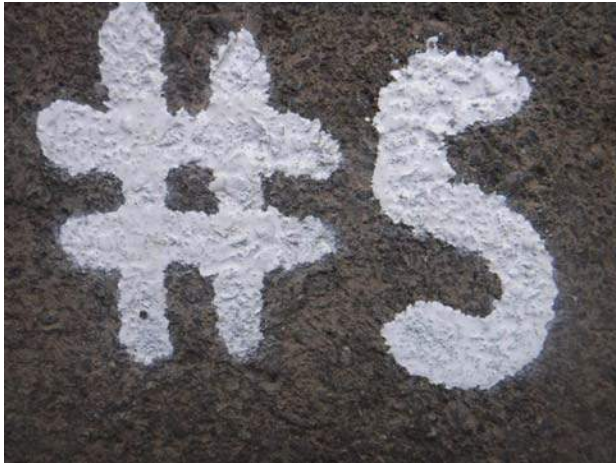
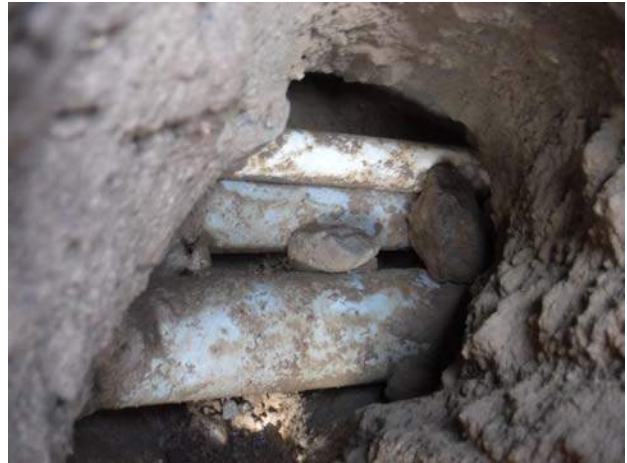
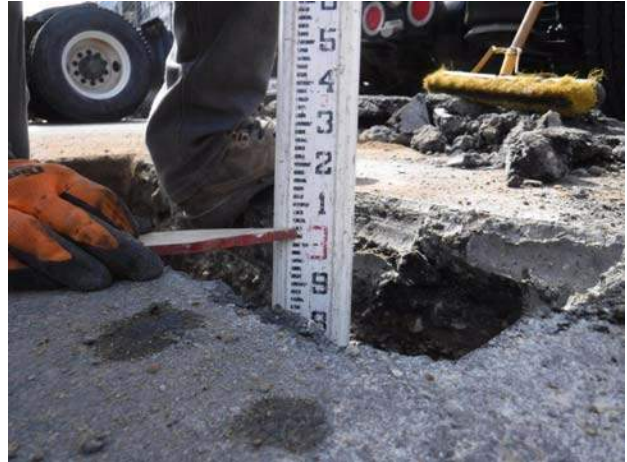
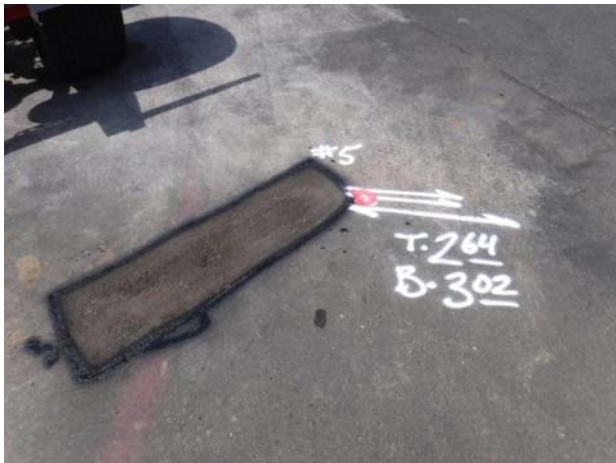
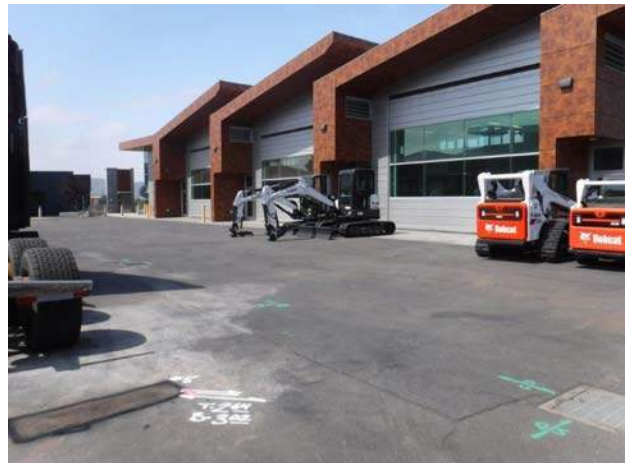
Pothole: 5

PH#	Station	Utility	Top (ft)	Bottom (ft)	Size	Type	Distance From Curb	Direction
5		F/O	2.64	3.02	1", 1.5", 2.5"	PVC	10.05 ft from SD grate	NW/SE

Comments					
<u>Operator:</u>	Munson, Tyler	<u>Technician:</u>	Iokia III, Samuel	<u>Vehicle:</u>	USI 6
<u>Field Log #:</u>	14028	<u>Log Date:</u>	07/17/2018	<u>Soil Type:</u>	Clay
<u>Asphalt Depth:</u>	0.50	<u>Concrete Depth:</u>	1.10 base	<u>Marker:</u>	PK Nail

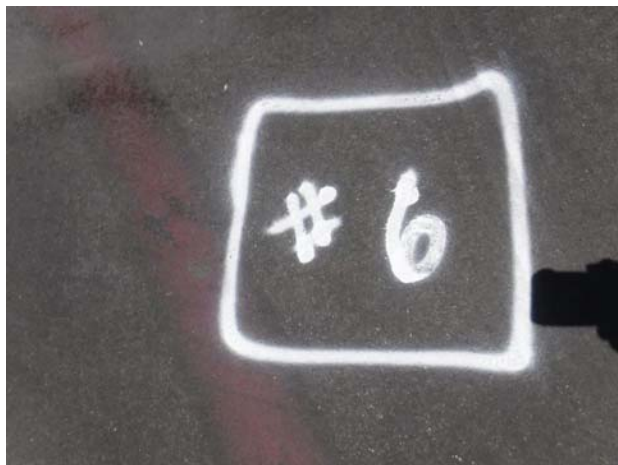
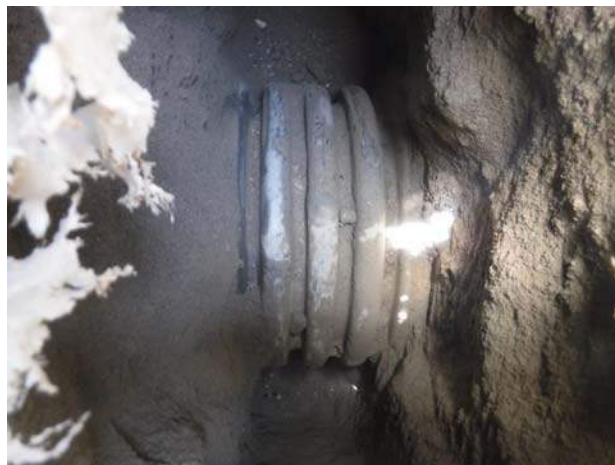
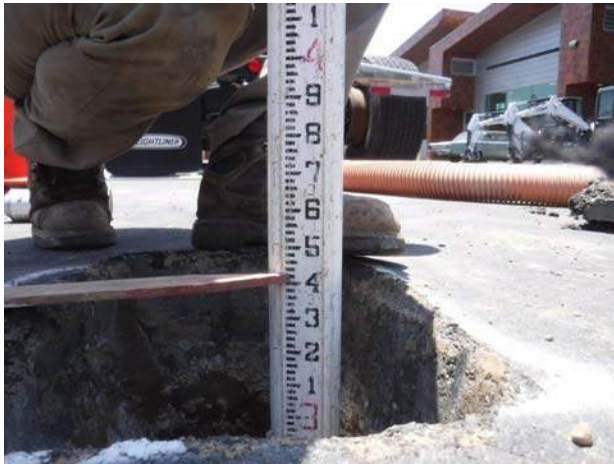
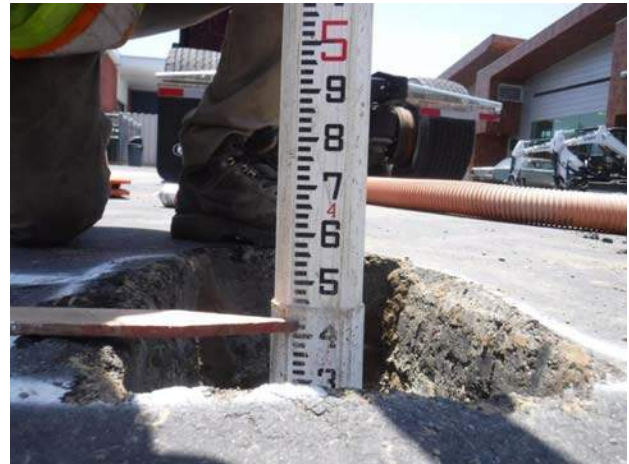
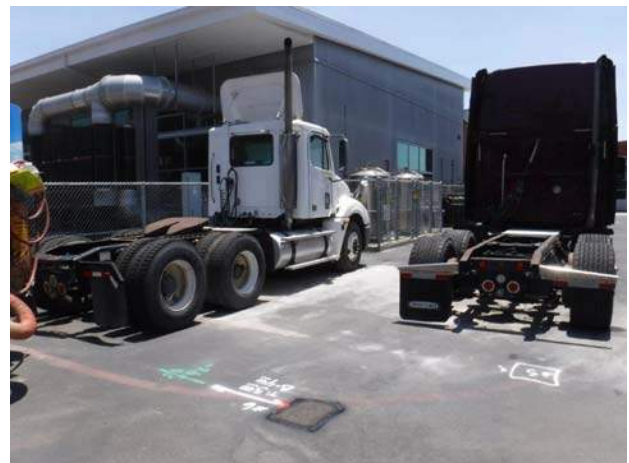
Pothole: 6

PH#	Station	Utility	Top (ft)	Bottom (ft)	Size	Type	Distance From Curb	Direction
6		SD	3.40	4.41	12"	CPVC	15.75 ft from SD grate	E/W

Comments					
Operator:	Munson, Tyler	Technician:	Iokia III, Samuel	Vehicle:	USI 6
Field Log #:	14021	Log Date:	07/16/2018	Soil Type:	Clay
Asphalt Depth:	0.35	Concrete Depth:	0.85 base	Marker:	PK Nail

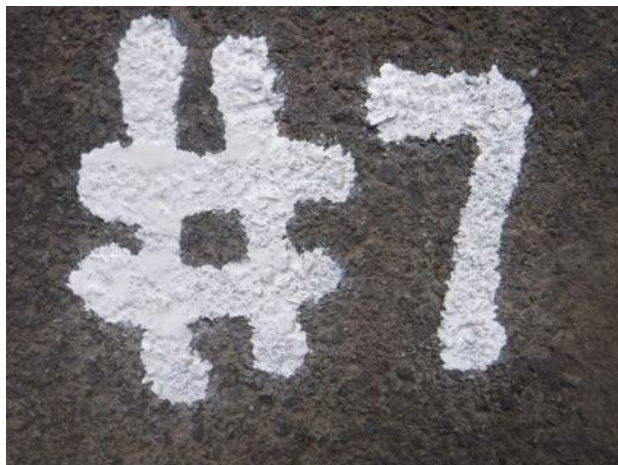
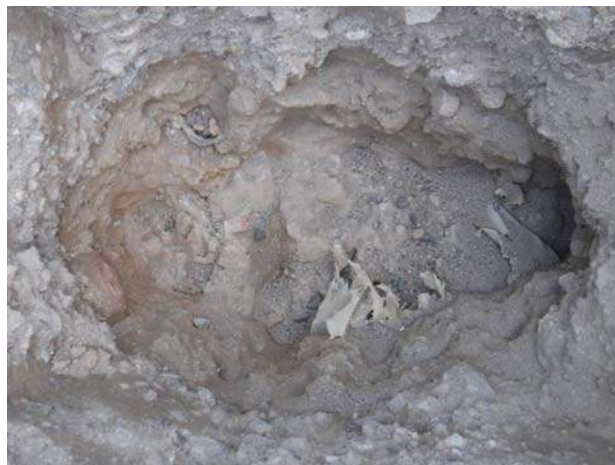
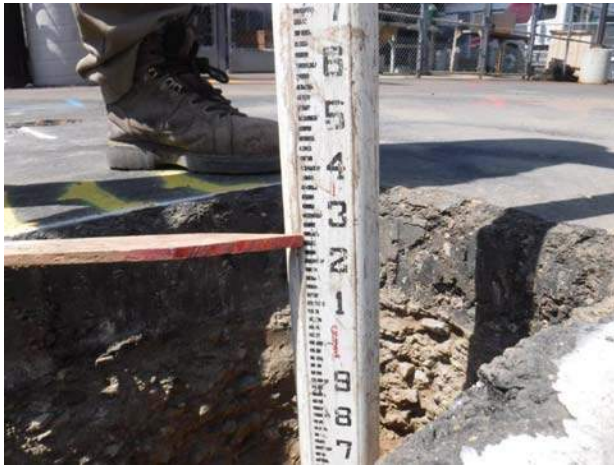
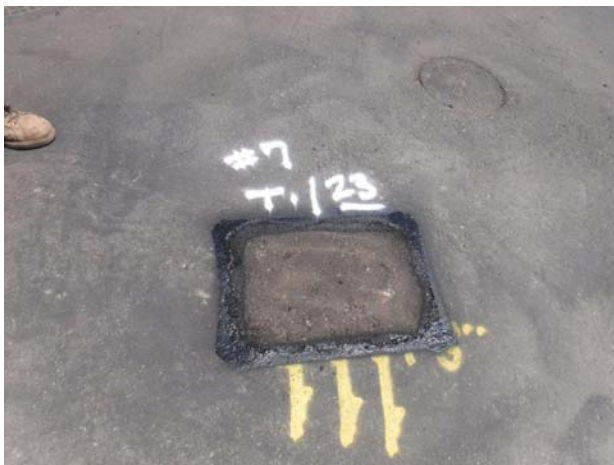
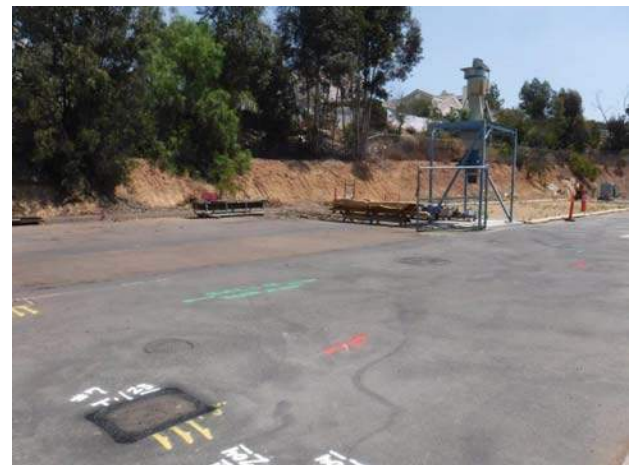
Pothole: 7

PH#	Station	Utility	Top (ft)	Bottom (ft)	Size	Type	Distance From Curb	Direction
7		E	1.23	0.00	UNK	ENC	14.50 ft from STLT	E/W

Comments	* Unable to expose bottom of ENC due to native/rocky soil conditions				
Operator:	Munson, Tyler	Technician:	Iokia III, Samuel	Vehicle:	USI 6
Field Log #:	14023	Log Date:	07/16/2018	Soil Type:	Clay
Asphalt Depth:	0.35	Concrete Depth:	0.85 base	Marker:	Paint

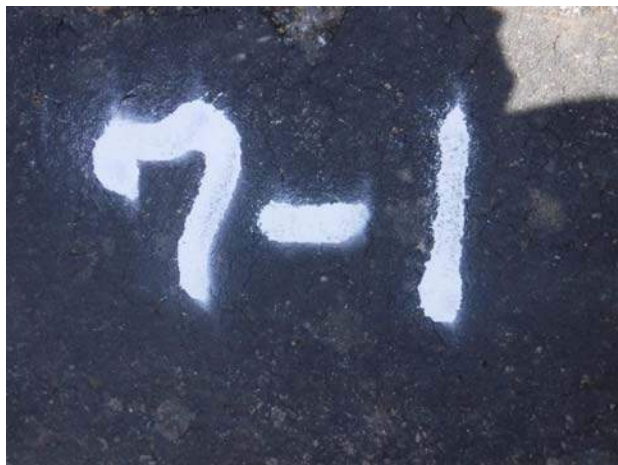
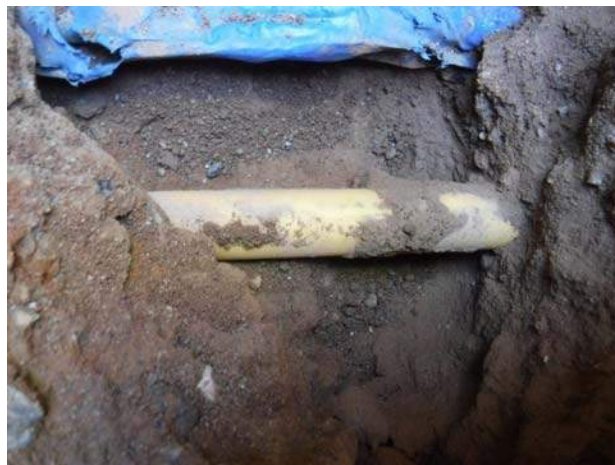
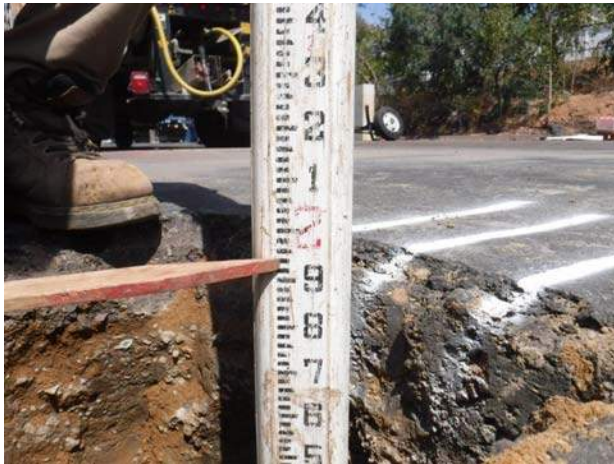
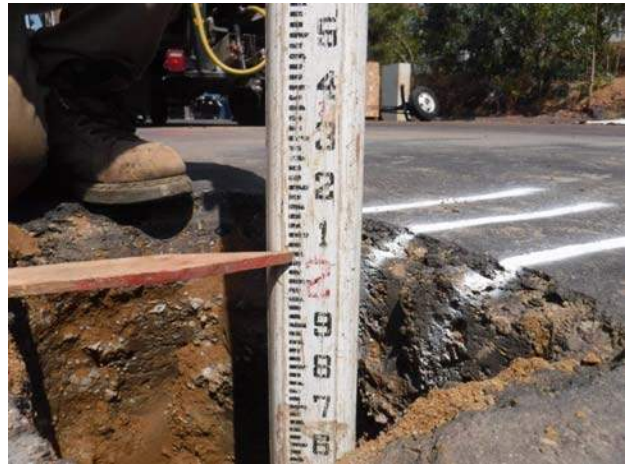
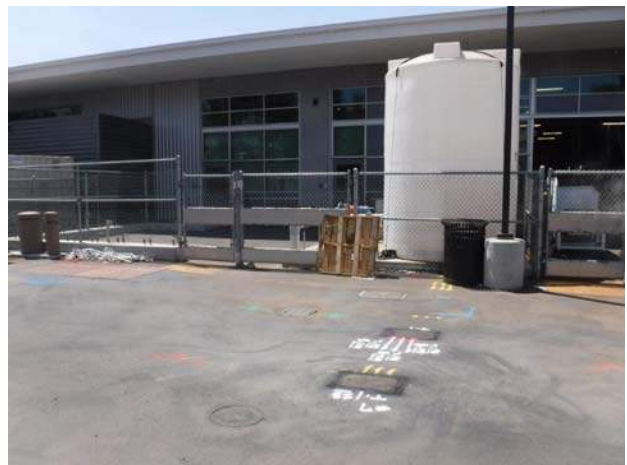
Pothole: 7-1

PH#	Station	Utility	Top (ft)	Bottom (ft)	Size	Type	Distance From Curb	Direction
7-1		G	1.92	2.04	0.75"	PE	10.00 ft from STLT	N/S

Comments					
<u>Operator:</u>	Munson, Tyler	<u>Technician:</u>	Iokia III, Samuel	<u>Vehicle:</u>	USI 6
<u>Field Log #:</u>	14023	<u>Log Date:</u>	07/16/2018	<u>Soil Type:</u>	Clay
<u>Asphalt Depth:</u>	0.35	<u>Concrete Depth:</u>	0.85 base	<u>Marker:</u>	PK Nail

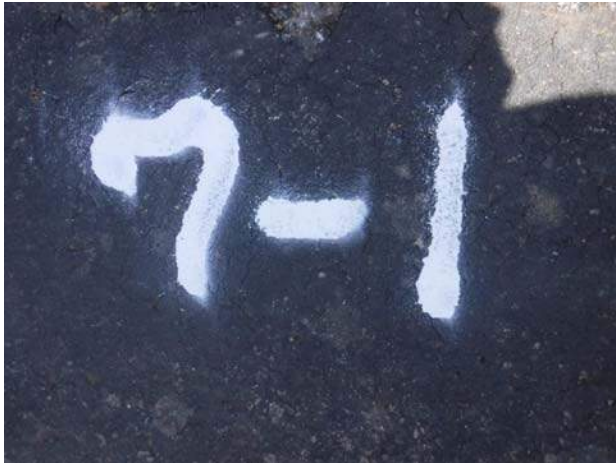
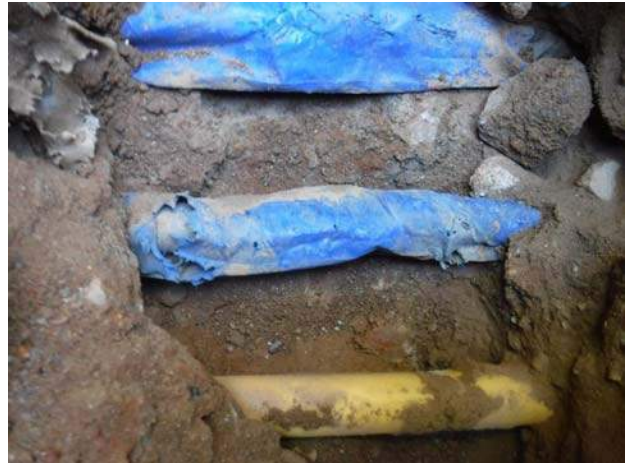
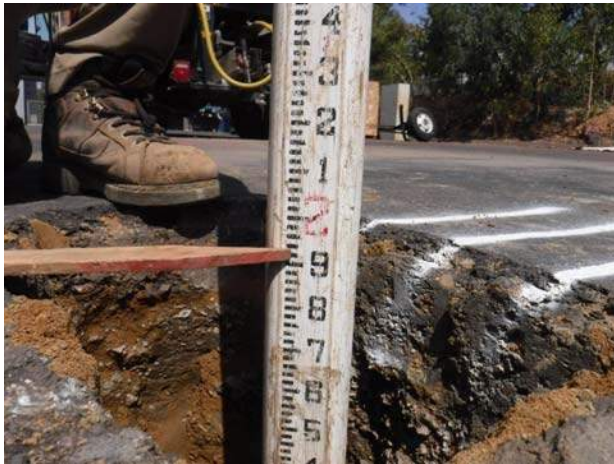
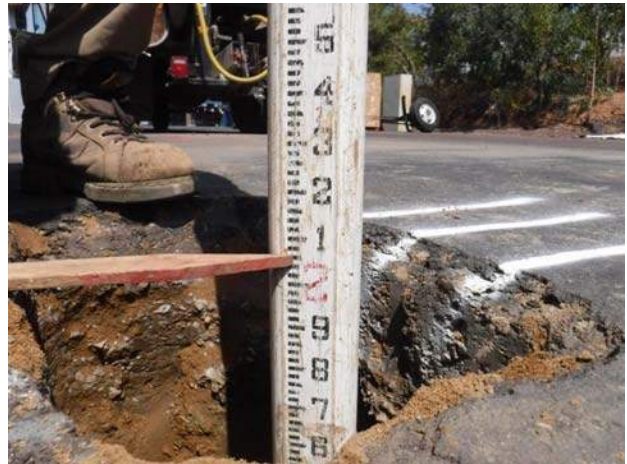
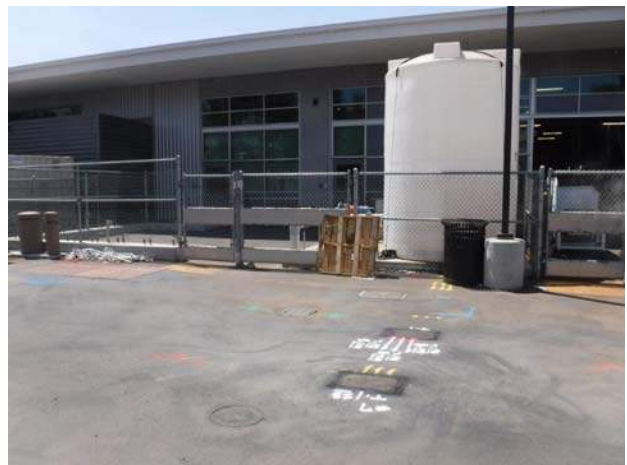
Pothole: 7-1

PH#	Station	Utility	Top (ft)	Bottom (ft)	Size	Type	Distance From Curb	Direction
7-1		W	1.91	2.04	0.75"	COPP	9.95 ft from STLT	N/S

Comments					
Operator:	Munson, Tyler	Technician:	Iokia III, Samuel	Vehicle:	USI 6
Field Log #:	14023	Log Date:	07/16/2018	Soil Type:	Clay
Asphalt Depth:	0.35	Concrete Depth:	0.85 base	Marker:	PK Nail

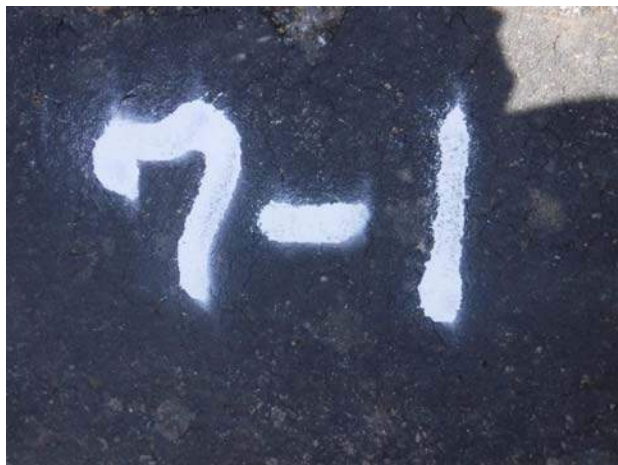
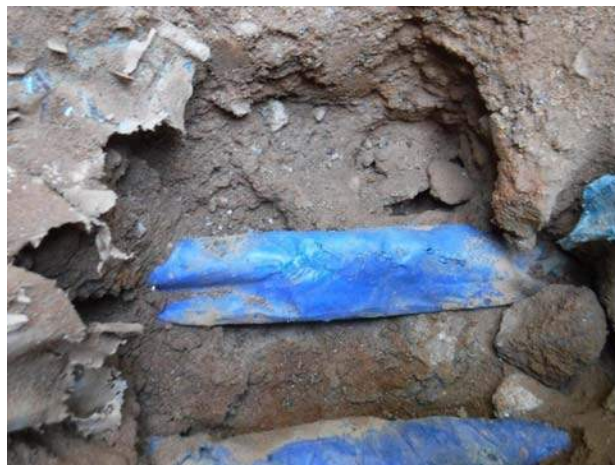
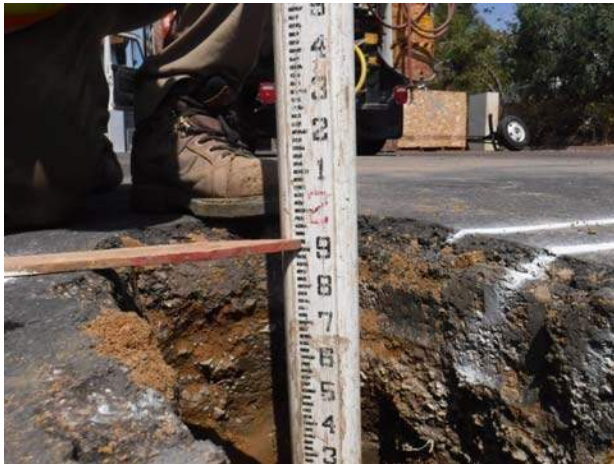
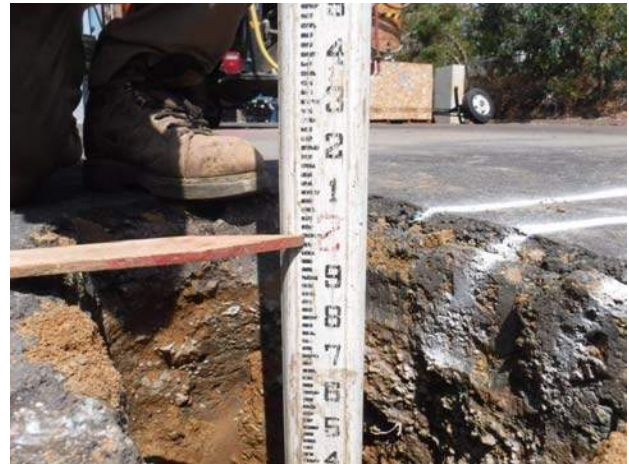
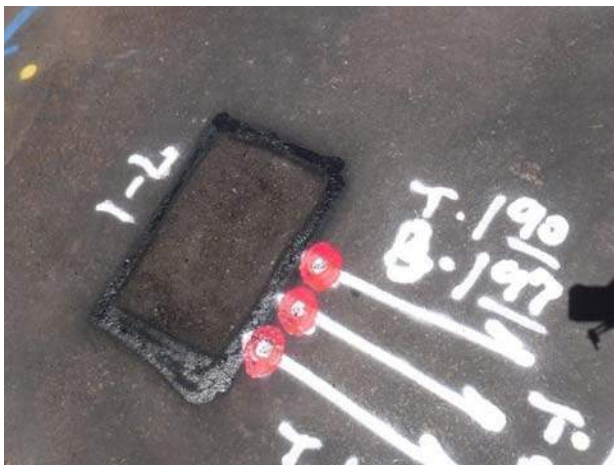
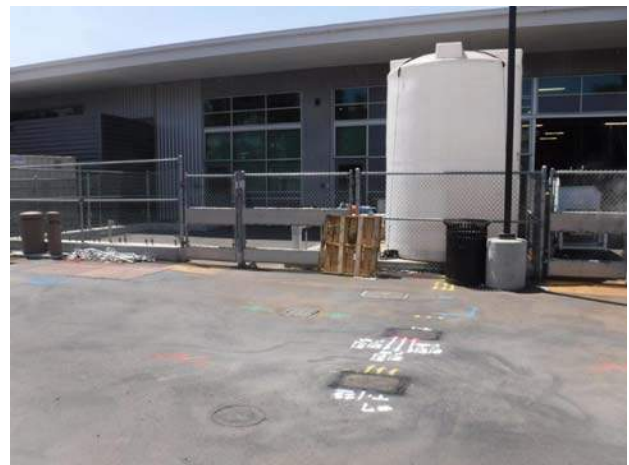
Pothole: 7-1

PH#	Station	Utility	Top (ft)	Bottom (ft)	Size	Type	Distance From Curb	Direction
7-1		W	1.90	1.97	0.75"	COPP	9.80 ft from STLT	N/S

Comments					
Operator:	Munson, Tyler	Technician:	Iokia III, Samuel	Vehicle:	USI 6
Field Log #:	14023	Log Date:	07/16/2018	Soil Type:	Clay
Asphalt Depth:	0.35	Concrete Depth:	0.85 base	Marker:	PK Nail

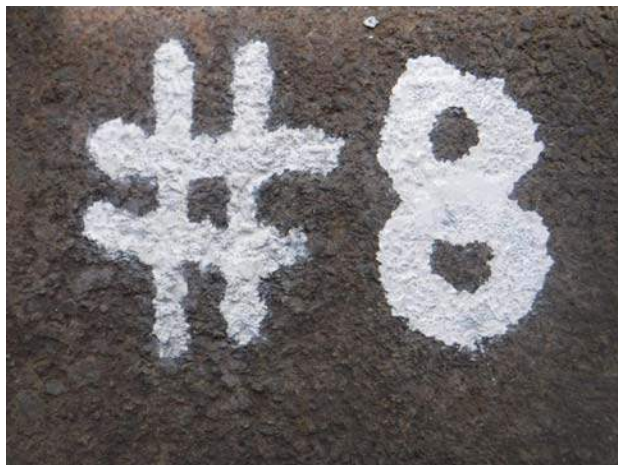
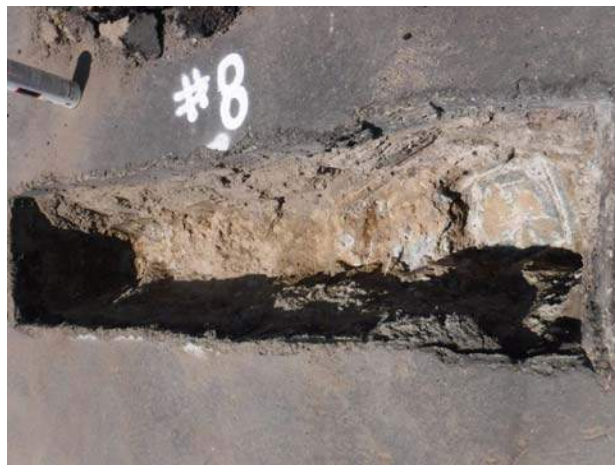
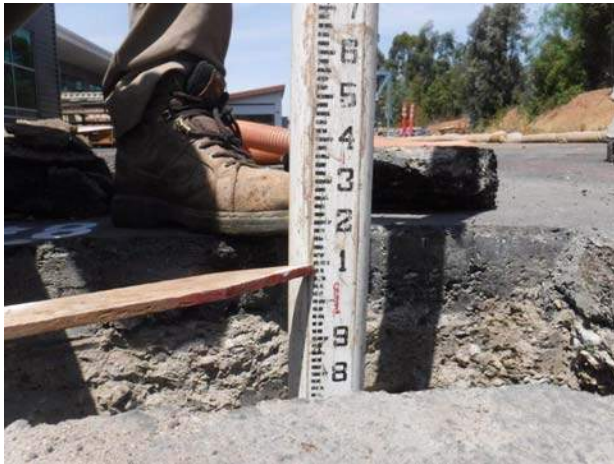
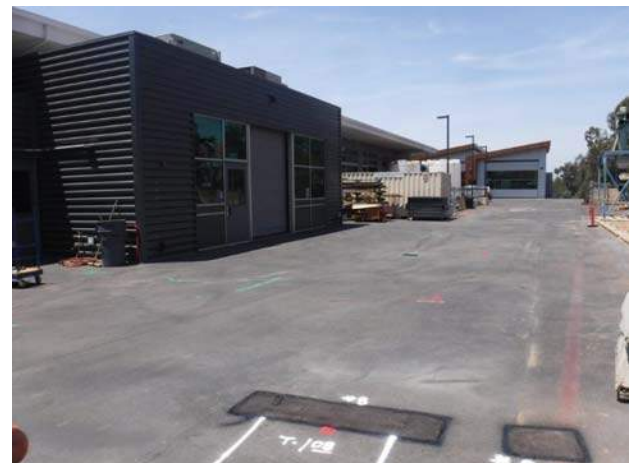
Pothole: 8

PH#	Station	Utility	Top (ft)	Bottom (ft)	Size	Type	Distance From Curb	Direction
8		E	1.08	0.00	3.10' wide	ENC	30.20 ft from corner bldg	E/W

Comments	* Unable to expose bottom of ENC due to native/rocky soil conditions				
Operator:	Munson, Tyler	Technician:	Iokia III, Samuel	Vehicle:	USI 6
Field Log #:	14021	Log Date:	07/16/2018	Soil Type:	Clay
Asphalt Depth:	0.35	Concrete Depth:	0.85 base	Marker:	PK Nail

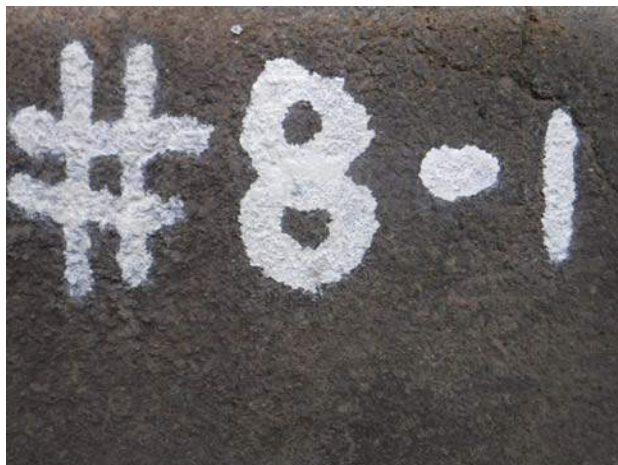
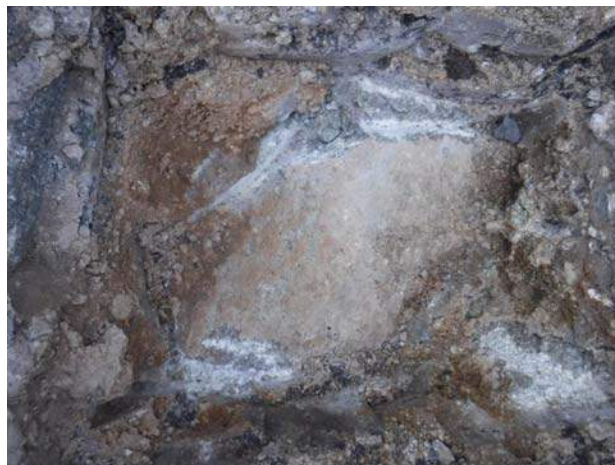
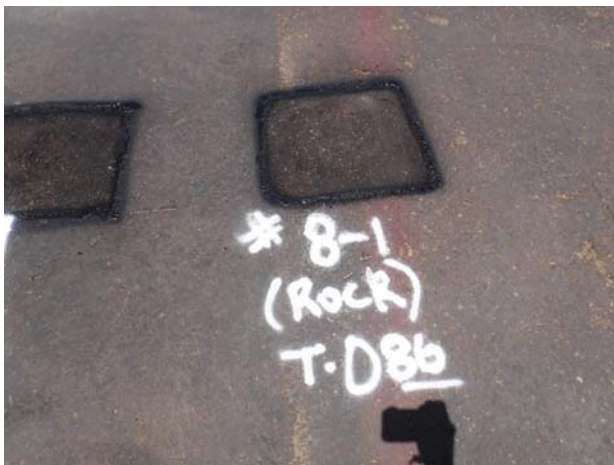
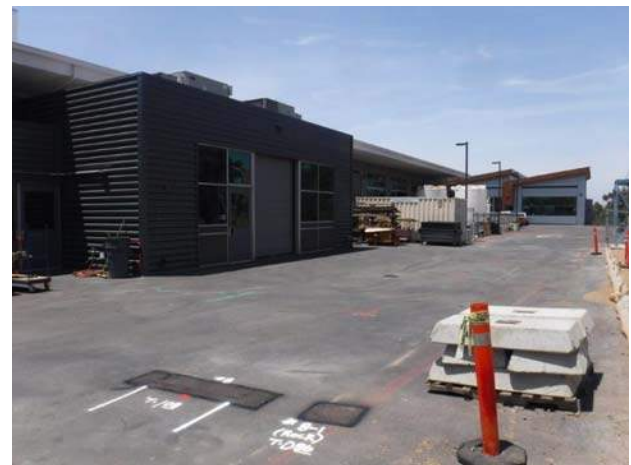
Pothole: 8-1

PH#	Station	Utility	Top (ft)	Bottom (ft)	Size	Type	Distance From Curb	Direction
8-1		Dry Hole	0.00	0.00		N/A		Unknown

Comments	* Native soil exposed at 0.86- unable to continue dig.				
Operator:	Munson, Tyler	Technician:	Iokia III, Samuel	Vehicle:	USI 6
Field Log #:	14021	Log Date:	07/16/2018	Soil Type:	Clay
Asphalt Depth:	0.50	Concrete Depth:	0	Marker:	Paint

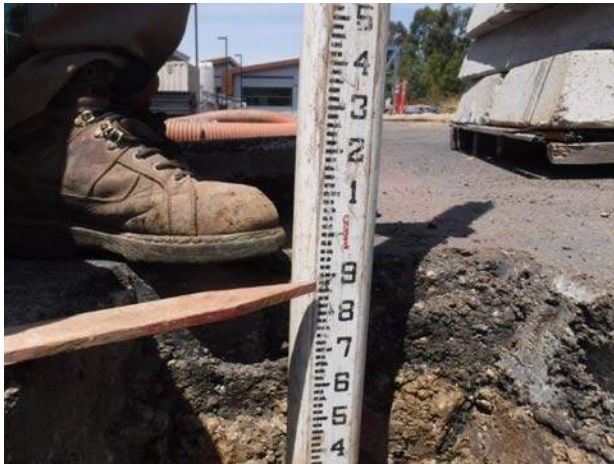
Top Depth Photo

POT HOLE #	8	Soil Type:	CLAY	Asphalt Depth:	035	Concrete Depth:	BASE 085	Plan Sheet#	-	Slot Trench: Width: 100 x Length 500 x Depth 108			
		Marker:	PK	Station #	-	Pre-Exc. Photo#	3154 3204	Area Photo#	3162	Comments:			
Utility:	E	Material Type:	CONC ENC	Size:	(WIDTH) 310	Utility Direction:	E/W	Distance from Curb:	3020 FROM CORNER OF BLDG	* UNABLE TO EXPOSE BOTTOM DEPTH OF ENC DUE TO NATIVE SOIL CONDITIONS. STOPPED ATTEMPT BY CUSTOMER REQUEST.			
Top Depth:	108	Bottom Depth:	-	Subsurface Photo#:	3155	Depth Photo (T) #:	3156	Depth Photo (B) #:	-	Finish Photo#:	3161	Additional Photo#	3160
POT HOLE #	8-1	Soil Type:	CLAY	Asphalt Depth:	050	Concrete Depth:	-	Plan Sheet#	-	Slot Trench: Width: _____ x Length _____ x Depth _____			
		Marker:	PANT	Station #	-	Pre-Exc. Photo#	3205	Area Photo#	3164	Comments:			
Utility:	N/A	Material Type:	-	Size:	-	Utility Direction:	-	Distance from Curb:	3500 FROM CORNER OF BLDG	* NATIVE SOIL CONDITIONS EXPOSED ROCK AT 080 UNABLE TO DIG PAST. (DRY HOLE) NO UTILITY FOUND.
