**PALOMAR RISK MANAGEMENT REPORTS**

Palomar Community College  
1140 West Mission Road | San Marcos, California

March 6, 2019 | Project No. 108182014

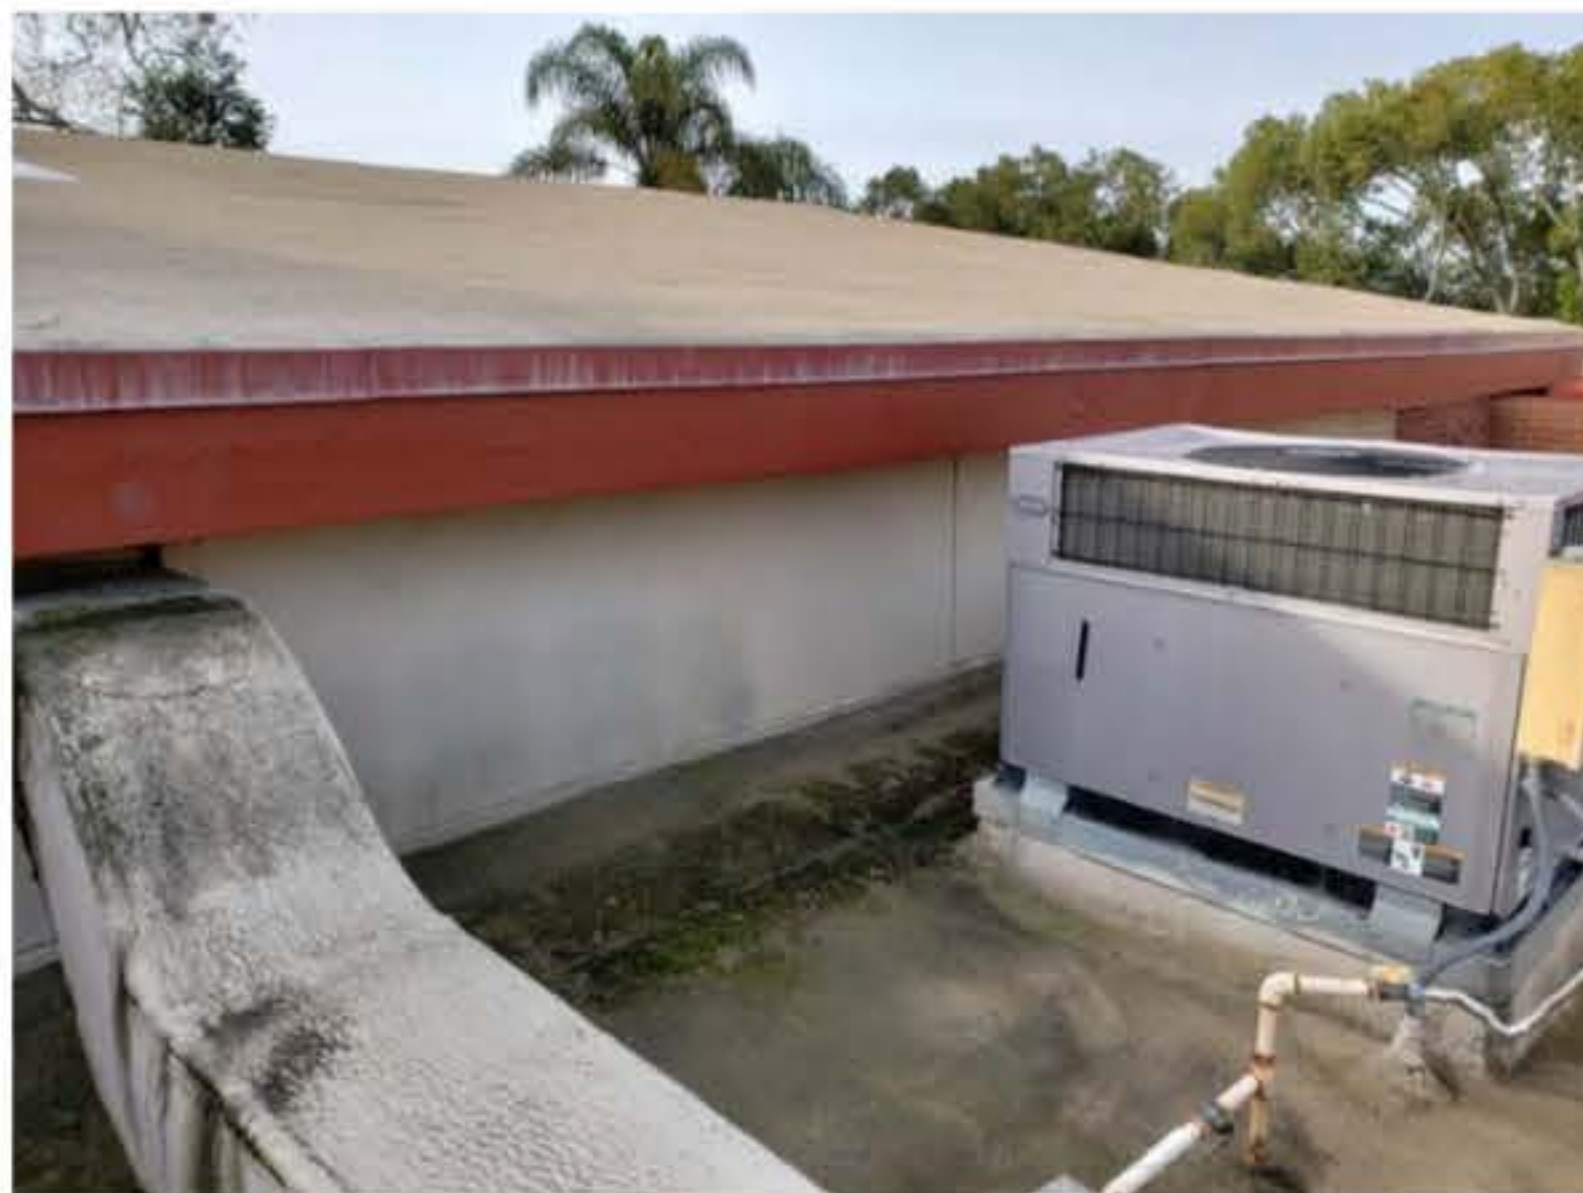
**Photograph 4:**

The SSC's interior spaces are supplied conditioned air from several roof-mounted Carrier® air handling units (AHUs) and all interior spaces appeared to be well ventilated and maintained at the time of our assessment. At least one roof-mounted AHU appeared to be brand new and several others were aged but appeared to be well-maintained. The installed air filters were reported to be rated at between MERV 8 and MERV 11 depending upon which AHU was being serviced. The observed filters were moderately dirty but are reportedly changed every 6 months. The next scheduled maintenance was reported to be sometime in March. All AHUs appeared to be operating normally and the accessible portions of the systems were very clean, visibly dry and free of debris and biological growth. One AHU however, operating directly above Office 15 and supplying air to Offices 14 through 16, was initially surrounded by mossy growth affecting the roof area. Photographs of this condition are shown in Appendix A.

**Another view of AHU supplying Offices SS-14 through SS-16, showing initial lack of rain gutter at roof edge.**

Recommendations were made to Palomar College that included cleaning of the biological growth on the roof, near the AHU identified above, increasing the MERV rating of this AHU from a MERV 8 to a MERV 11, installing rain gutter at the roofline above the AHU and collecting confirmation air samples in offices SS-10, SS-11, SS-14, SS-15 and SS-16 after completion of these remedial actions and professional cleaning of these offices. This confirmation sampling was accomplished on March 1, 2019 after confirming that cleaning had been started on the roof above and that new MERV 11 filters were installed. Rain gutter installation had also been completed however further cleanup of biological growth was needed and this was reported to Palomar College the same day.

Our recommendations associated with this assessment included installing a rain gutter at the roof edge above the AHU supplying Offices SS-14 through SS-16, replacing all remaining MERV 8 filters with MERV 11 filters, establishing an inspection schedule to help ensure the roof areas are kept free from biological growth and continuing to pay attention to indoor air quality concerns from building occupants. At the time of this writing, some biological growth is still present on the roof top but further cleaning has reportedly been scheduled. No further action is recommended concerning further specialized investigation of indoor air quality at this time.

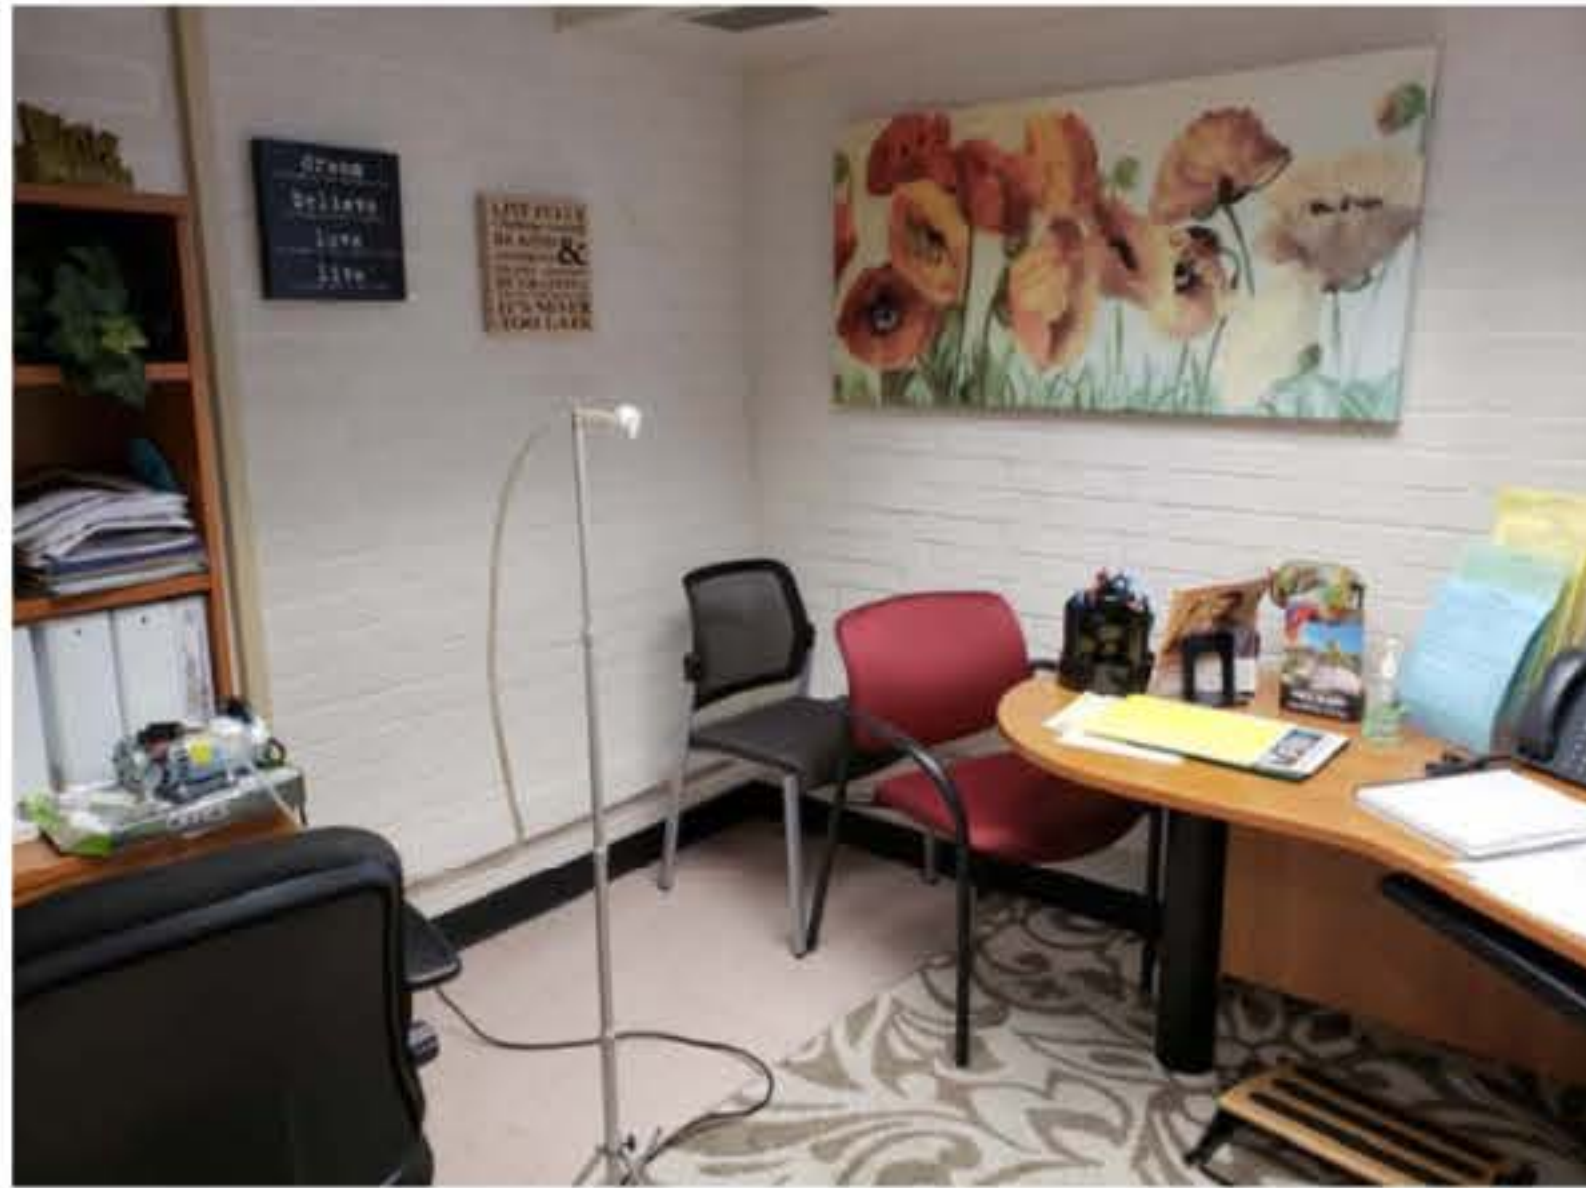
**Photograph 5: Office SS9-Particulate Sampling**

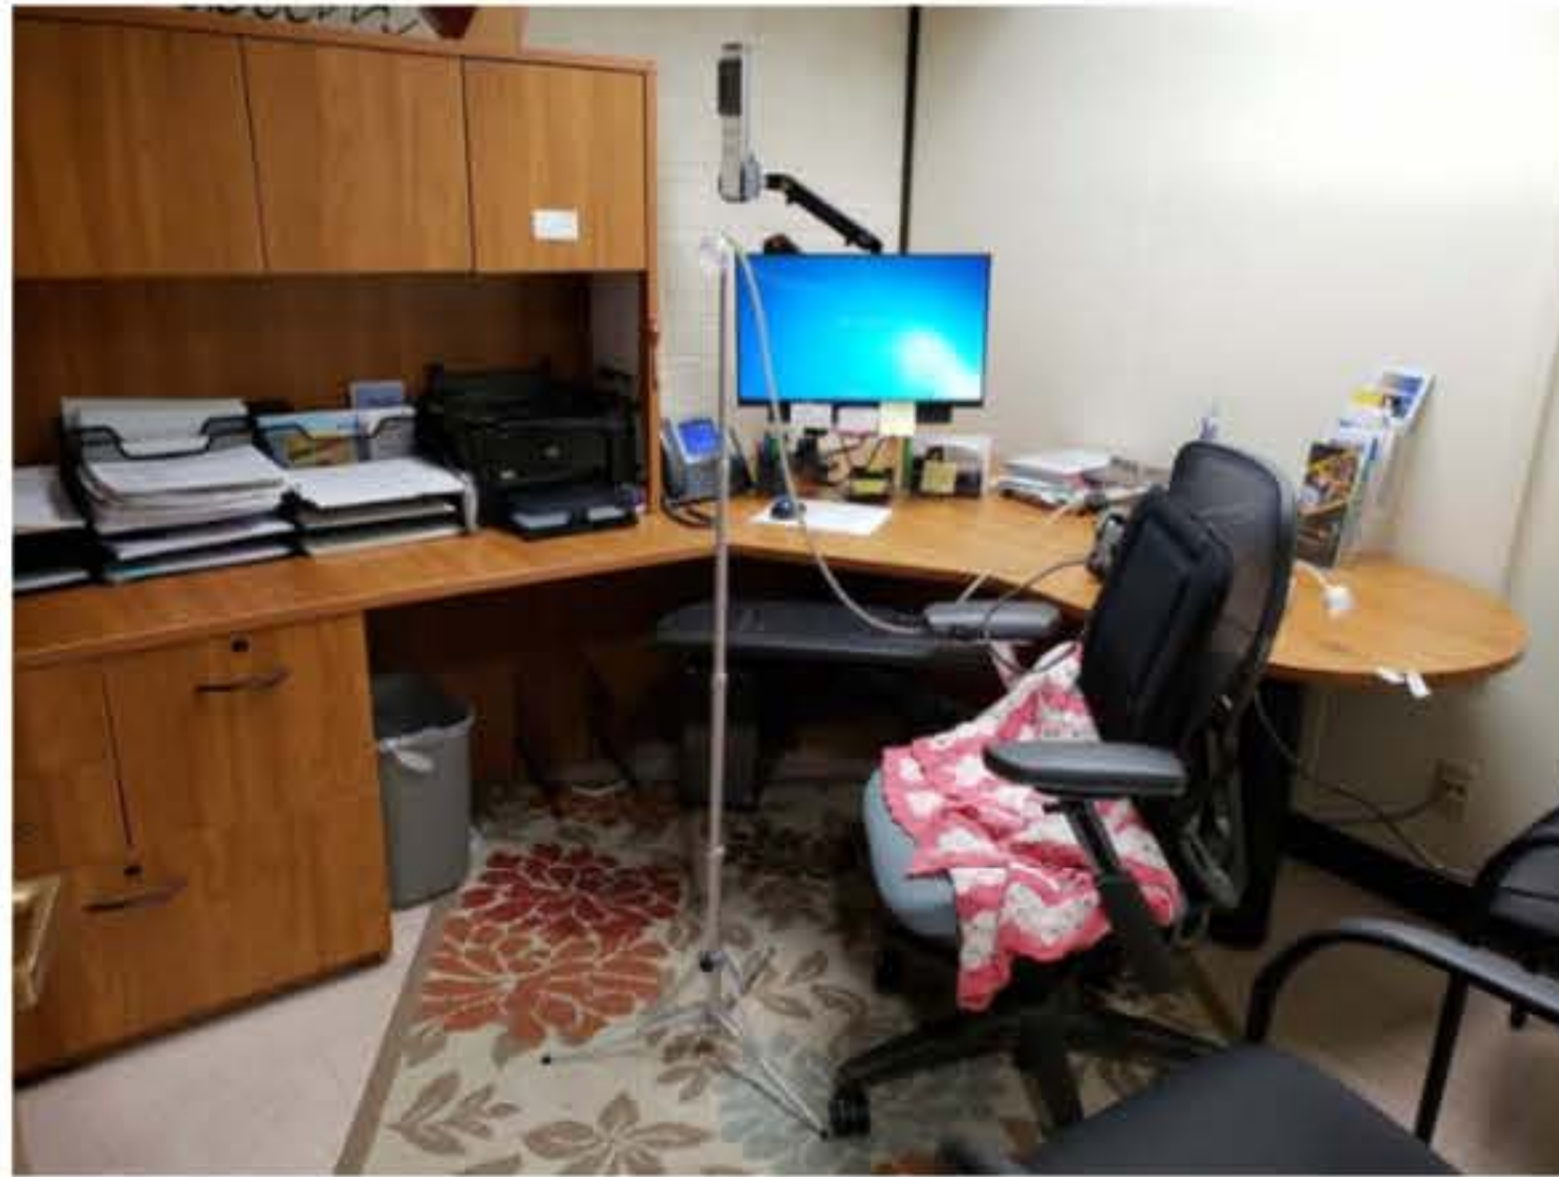
Results of the spore trap samples collected from the interior of the SSC Building were compared to the exterior (background) sample results. In our original sample set, collected on February 19, 2019, one spore type (*Penicillium/Aspergillus*) was found in slightly elevated concentrations in Offices SS-10, SS-11 and SS-16. This mold is commonly found in house dust and on water-damaged wallpaper and/or acoustic ceiling tiles, as well as on outdoor sources. Since water-damaged ceiling tiles were being replaced during our assessment on February 19, it was suspected that this activity was the source of these airborne spores but ceiling tiles were not being disturbed in Office SS-16 where this spore type was also elevated. Palomar College immediately authorized additional investigation in these offices and a secondary assessment was conducted on February 26, 2019.

**Photograph 7:**                      **Office SS11-Particulate Sampling**

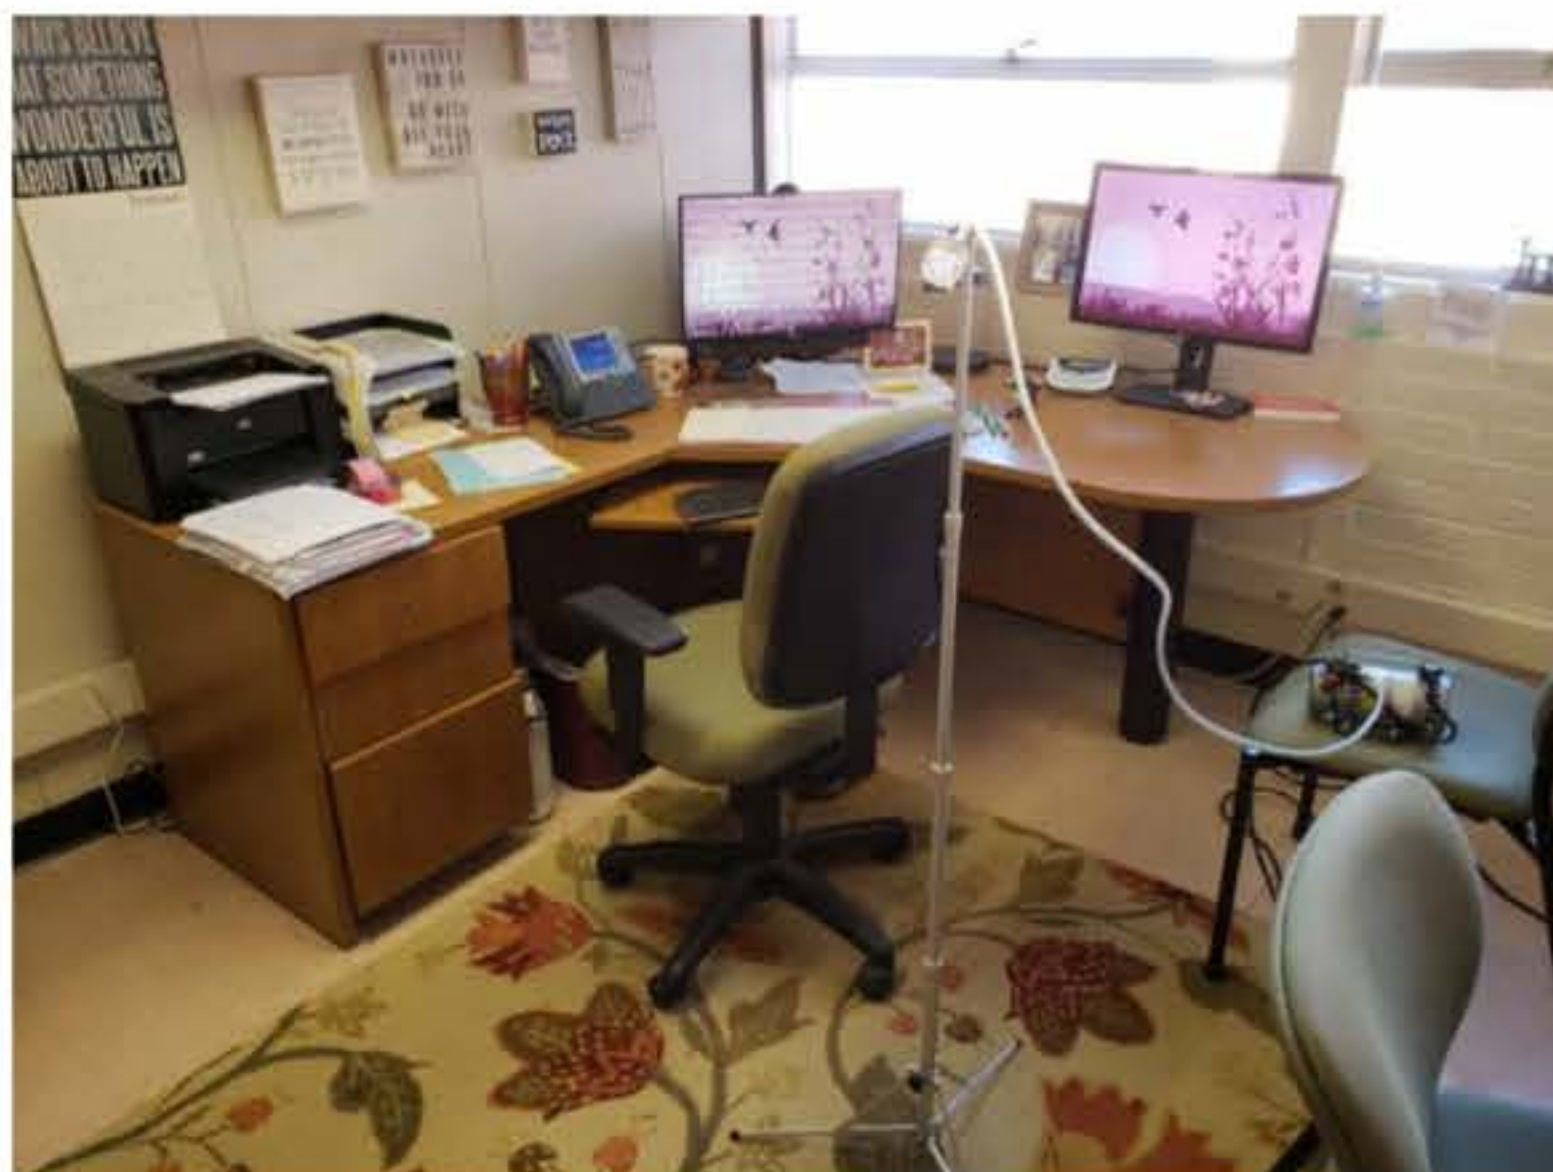
**Photograph 8:**                      **Office SS16-Particulate Sampling**

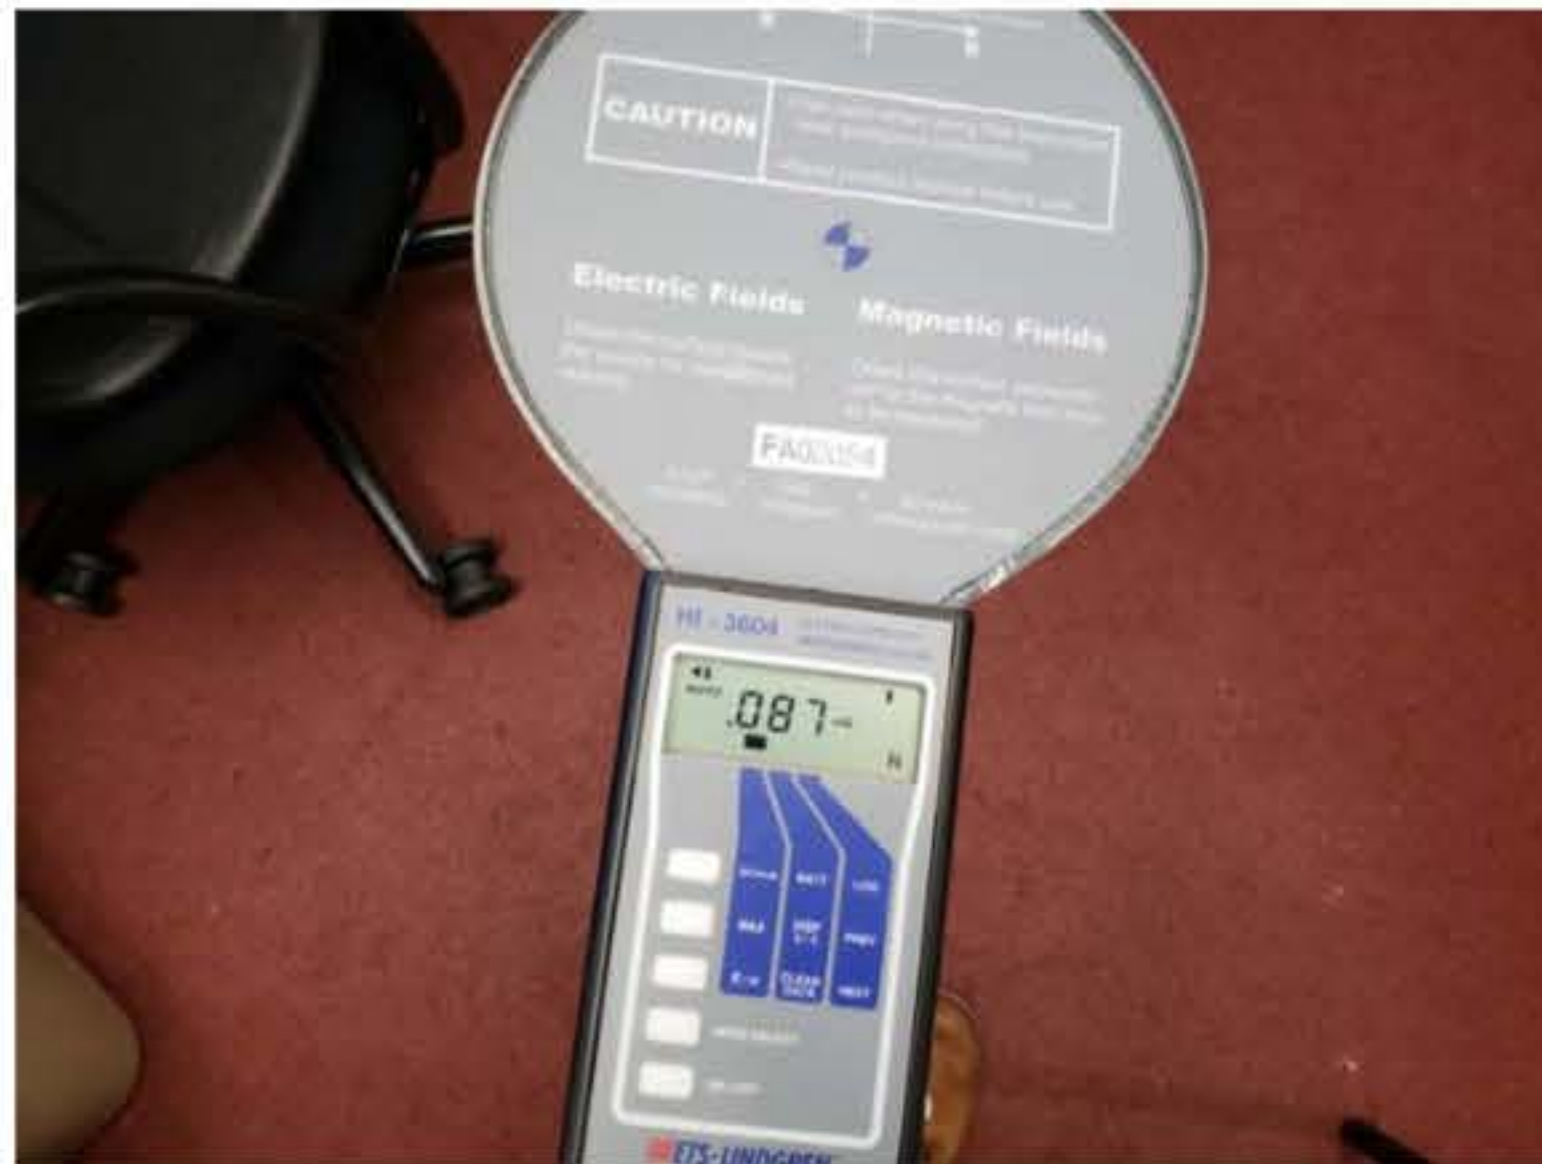
Meter readings obtained within the Electrical Room ranged from 7.9mG at the approximate room center to approximately 50mG upon contact with the transformer. Readings obtained outdoors at the perimeter walls ranged from approximately 0.4mG (west side) to approximately 4.0mG (north side). Meter readings within the occupied offices adjacent to the Electrical Room ranged from approximately 0.08mG to 0.40mG at room centers with the highest readings on contact with the north wall in Rooms SSC-11 and SSC-12 at 1.65mG and 1.50mG respectively. Meter readings at each individual location are noted in Figure 2, provided in Appendix B.

Photograph 9: Office SS10-EMF Measurement

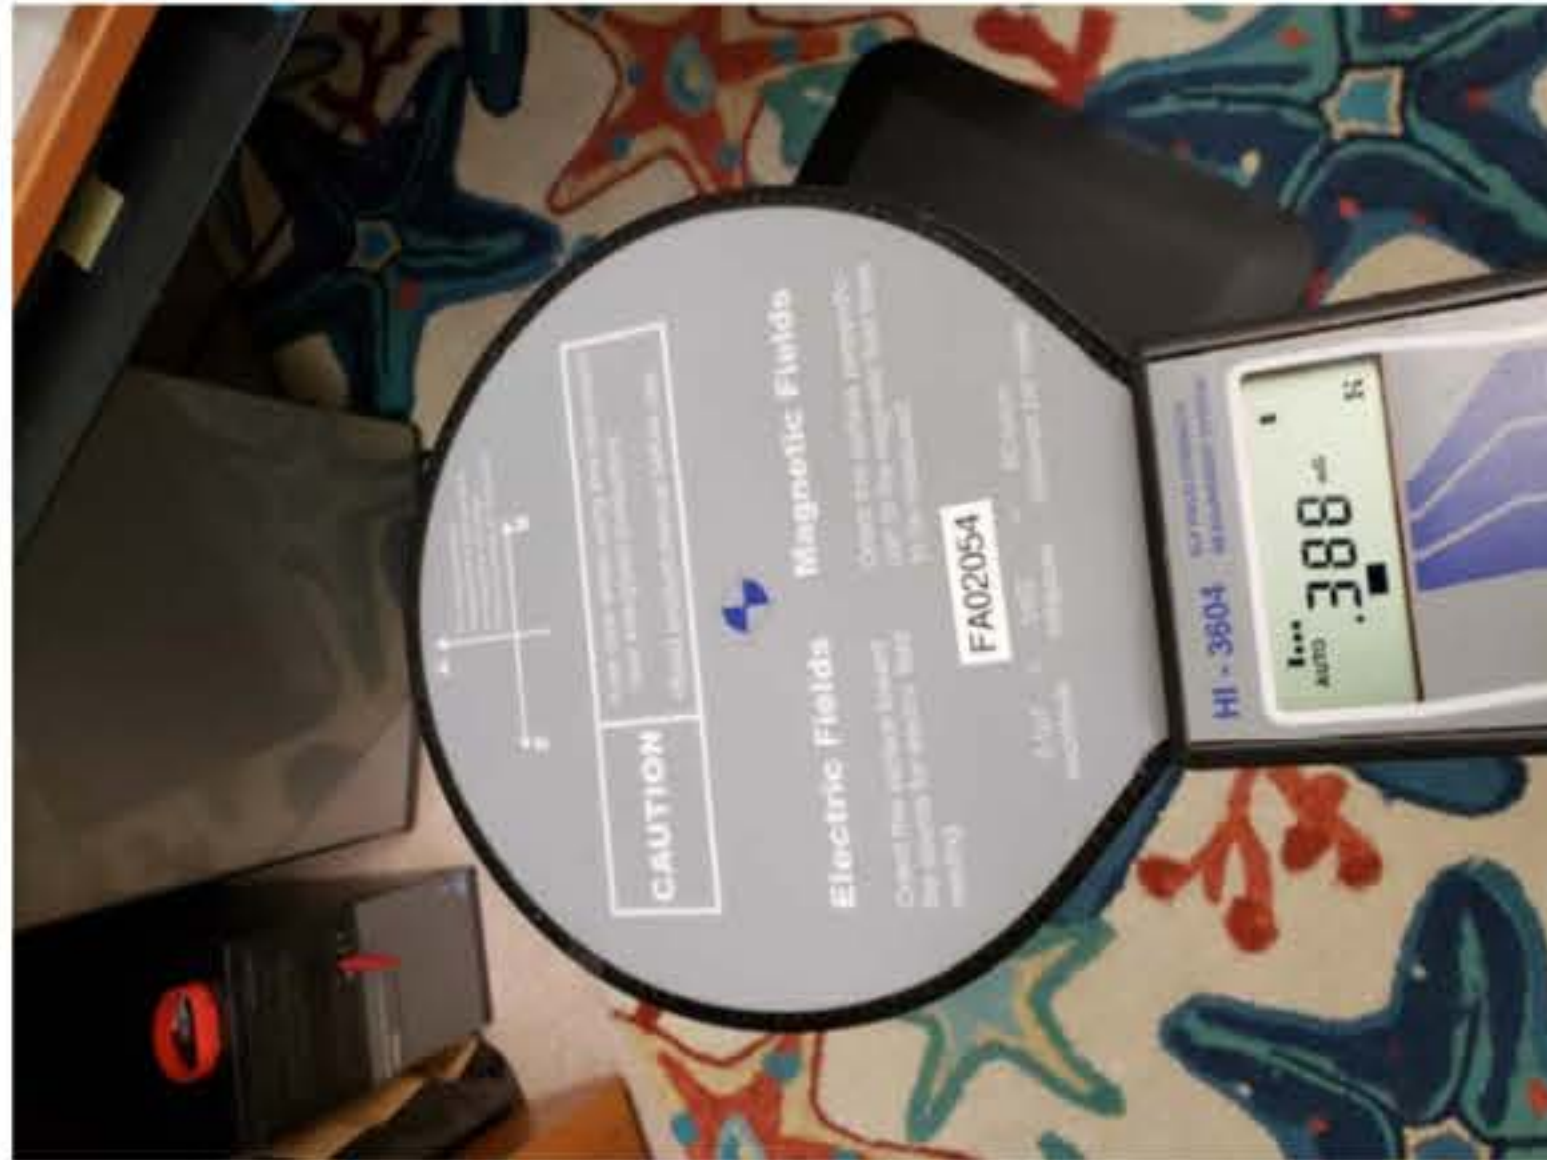
**Photograph 11:** Office SS12-EMF Measurement

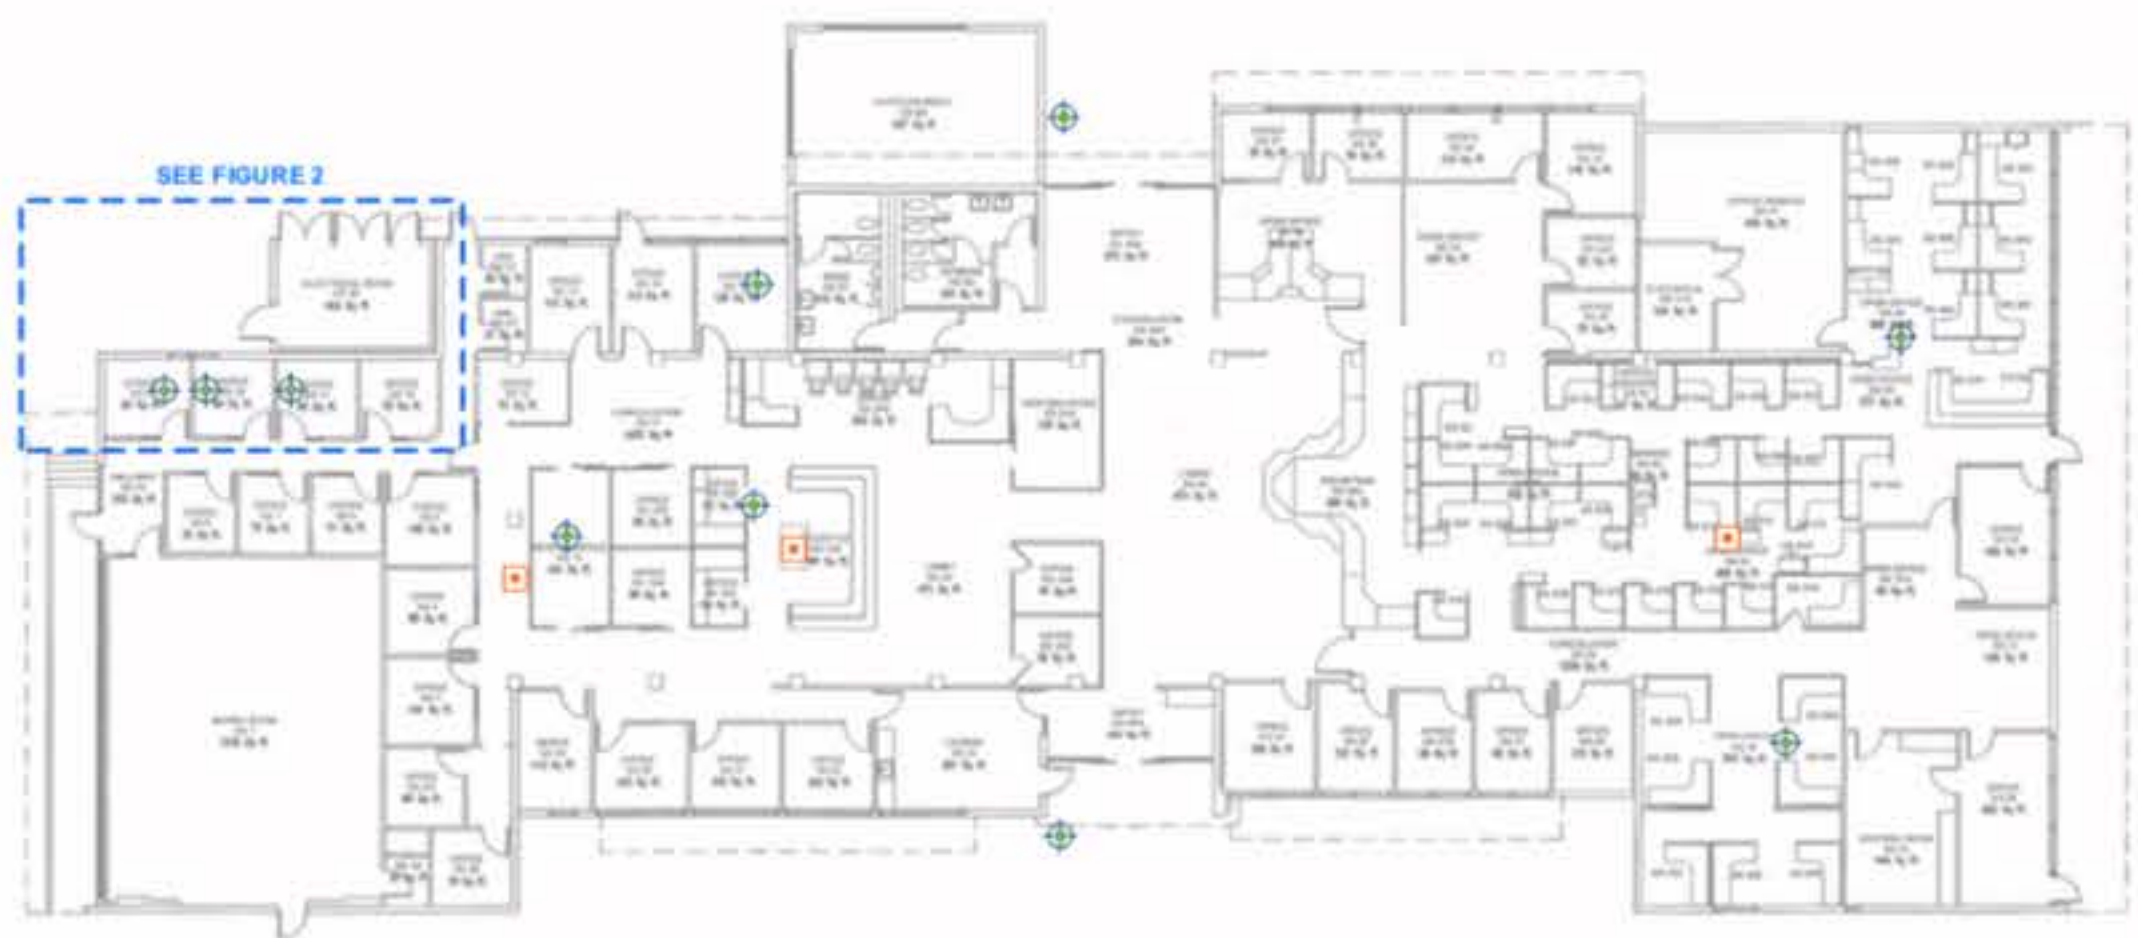
The three evacuated canisters were staged in the busier areas of the building to capture a representative sample of the indoor air for subsequent analysis via mass spectroscopy. The areas sampled are shown in Figure A of Appendix B and represent the Front Desk, West Area, and the Records/Admissions area. Results of the laboratory analysis of indoor air within the sampled areas indicated the usual levels of indoor air contaminants with the highest concentrations being ethanol, acetone and isopropyl alcohol. Ethanol, isopropyl alcohol and acetone are almost always found in indoor environments in low concentrations due to the use of cleaning products.

- LEGEND
- EVACUATED CANISTER SAMPLE LOCATION (GASES/VAPORS) (3)
  - ⊕ PARTICLE SAMPLER LOCATION (10)
