FENCE TEAM WORKING NOTES

This file will be modified each week as we build our fences. Any ideas should be recorded in this file.

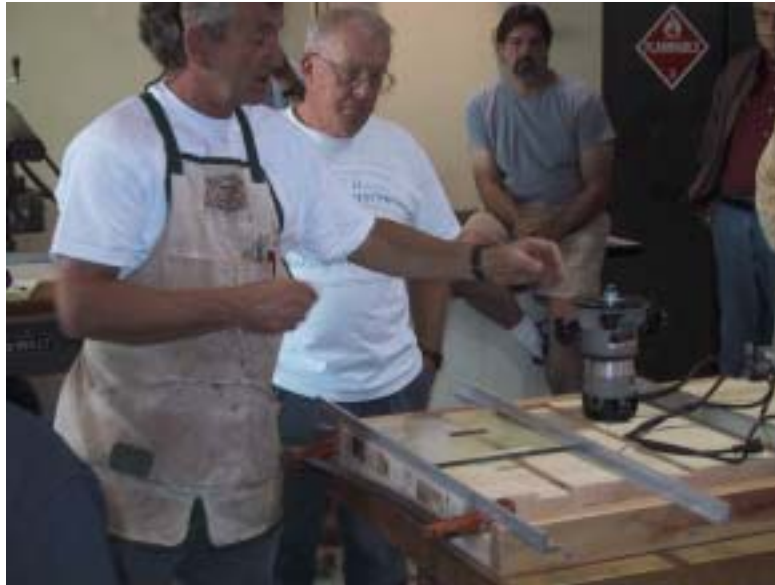
Started with a team meeting to discuss the construction of the fence. Progress today includes preparation of all stock for the sliding fence and half of the fence top piece. All middle pieces of the back of the fence were completed and all dados rough-cut. The jig was completed to finish the dados for the middle piece and about 10 pieces were completed before running out of time. Below is a picture of the jig:

The jig for finishing the four dados in the middle of the fence was displayed for the entire class. In checking progress with this jig it was found that the dados were too deep. Several changes were made to the jig to improve performance. These include lowering the sides and squaring the entire jig. It was decided that some of the rough dados made by the saw were also too deep. This is not a serious problem as long as the bottom piece is milled to exact 1.5 inch.

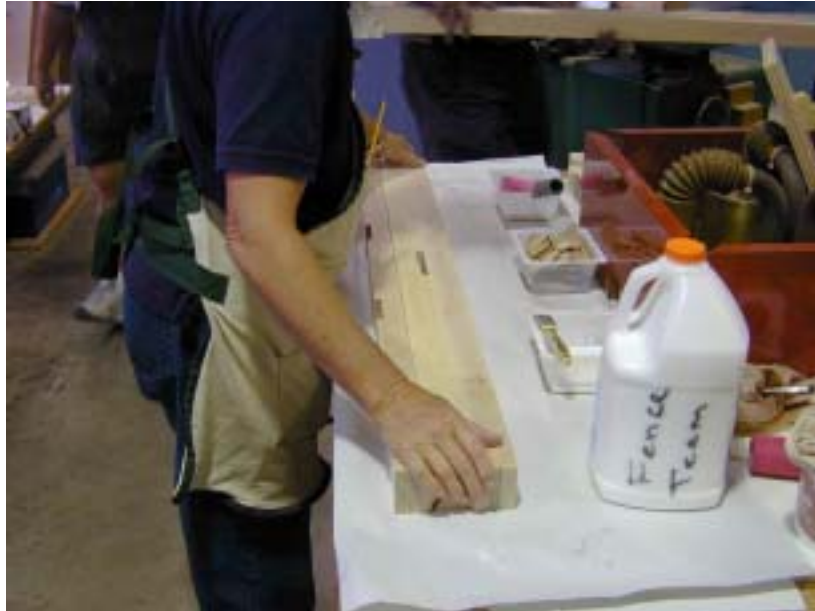
1. The remaining 15 back units of the fence were glued up. See photo below:

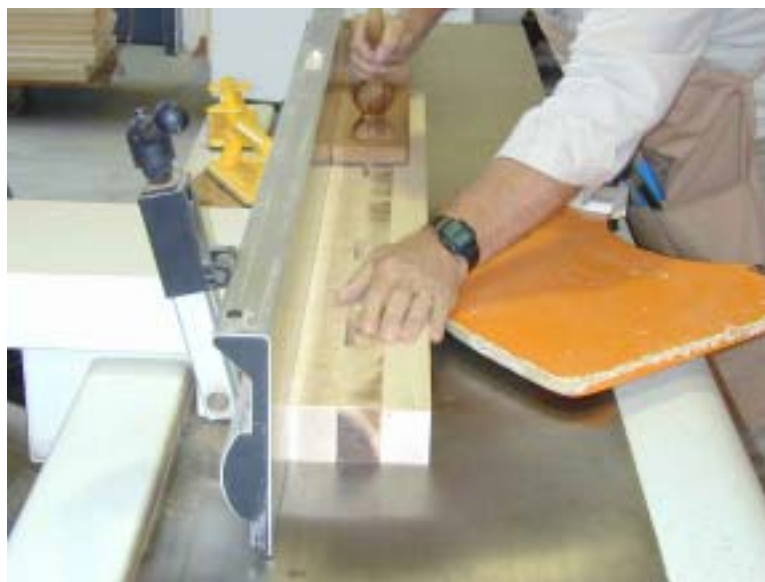
2. The sliding fence pieces (two per fence) were all milled to a consistent $2 \frac{7}{8}$ inches in height.
3. The first 20 back units were jointed so that the front and bottom were at right angles. See photo below to see operation. Then the back was planed.

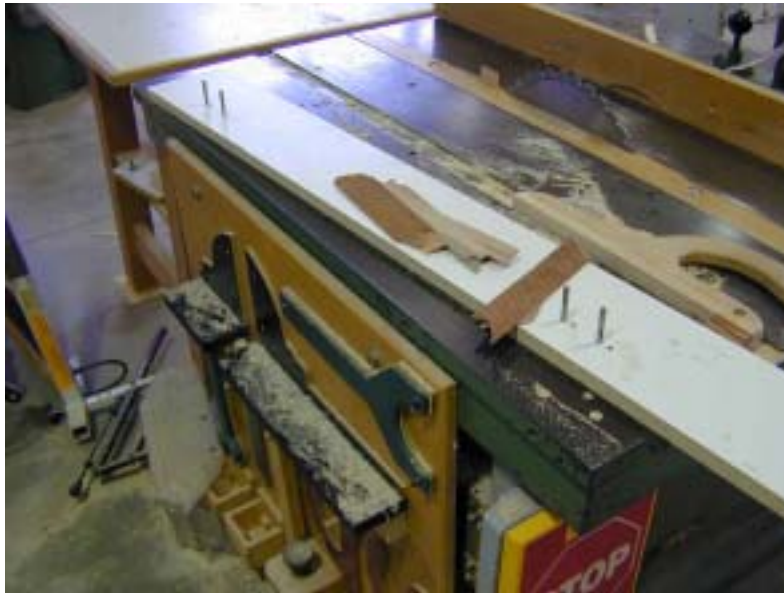
4. A soft jig was made to cut the bottom piece at 1.5 inches in height. This is important to insure that hardware connecting the sliding fence is in the correct position. The slots in the middle board of the back fence were to be used to register the jig. That is, the pins were positioned exactly the same distance from the edge of the jig that slides along the saw fence. The piece is forced in position by using shims to so that the board is held in the position so that the saw can cut at exactly 1.5 inches from the pins. The photo below shows the jig and shims.

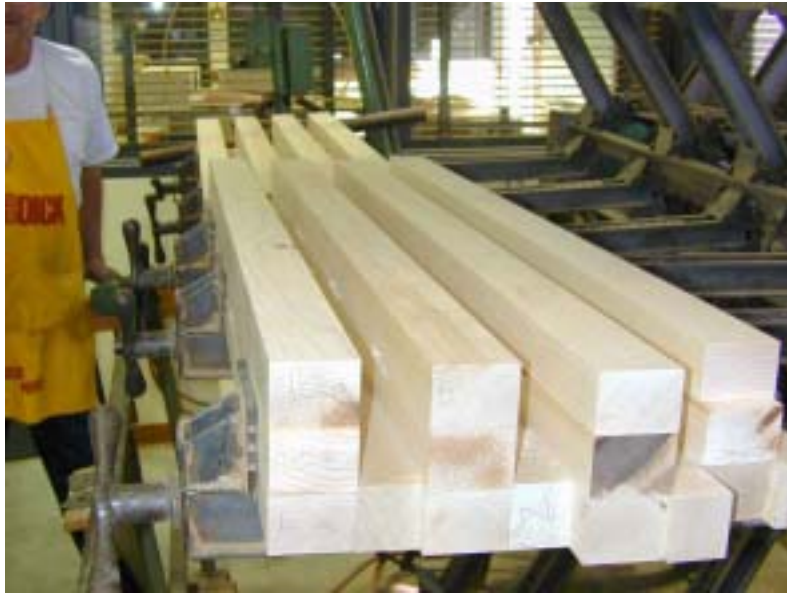
5. The front top pieces were then cut to final size in the vertical dimension so that it matched the height of the back part of the fence. They were then glued to the back of the fence. See photo below showing pieces in the gluing frame. A total of 20 were completed. The remaining units will be completed next time. Note that this front piece and the sliding fence pieces were milled at the same time to ensure that the “overhang” was exactly the same thickness as the sliding fence pieces. The sliding fences were sized vertically to correspond to the height of the bottom and center portions of the fence.

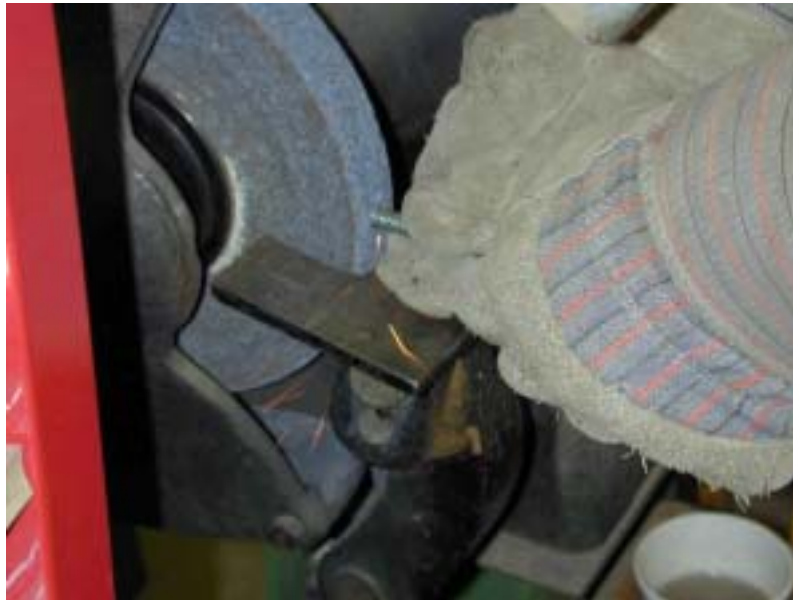
4. A special chop saw with an abrasive blade was used to cut the threaded bolt stock into pieces for the fence – each fence needs 6 pieces – almost all were completed. Each fence requires two pieces of drill rod stock that are used as locator pins for the fence clamps. Almost all of these were cut. Each bolt piece and drill stock piece was ground smooth, see photo below:

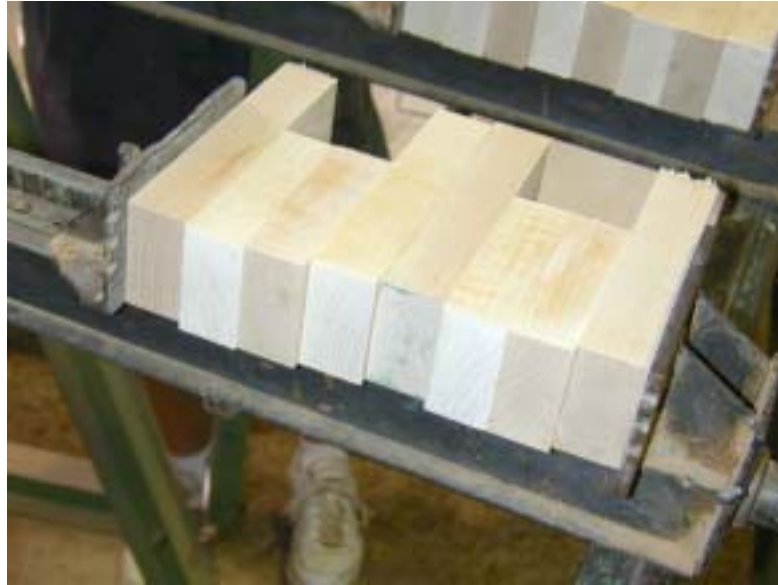
1. All the necessary all thread pieces have been cut and ends polished. Also, all of the 3/8 drill rod stock have been cut. A total of 50 feet of 5/16 all thread rod and 15 feet of 3/8 drill rod stock were required.
2. All the inserts have been installed in the sliding fence. The “automatic” tool required a lot of patience to operate – the drive chuck does not grip reliably all the time, so many were installed by hand.
3. All the fence clamps were constructed and glued up. Next they will be milled to final size. The photo below shows several in glue rack:

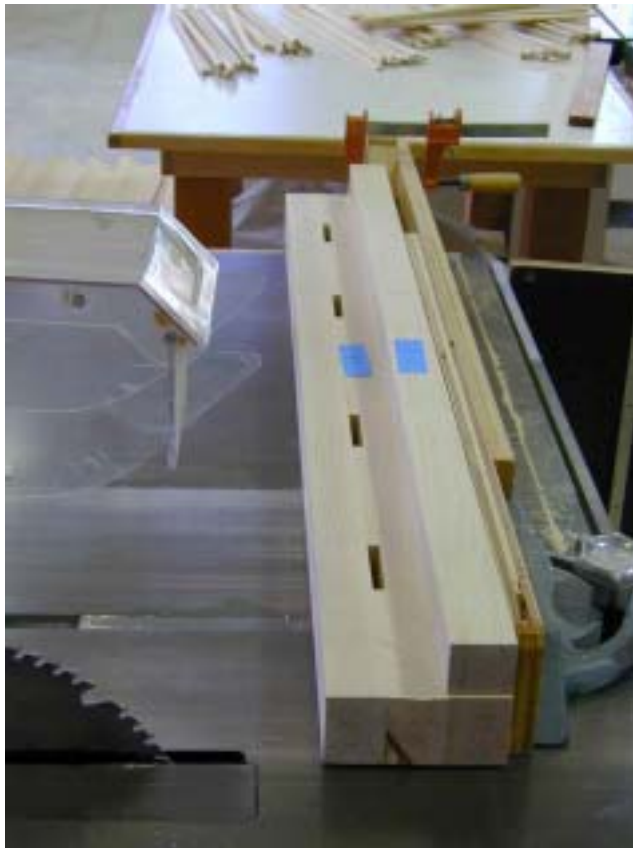
4. All 33 fences were cut to a final length of 41 inches. The procedure was to index off the center line mark of the fence and then cut the right end. Next a simple jig was made to ensure that every fence was exactly 41 inches in length. See next photo:

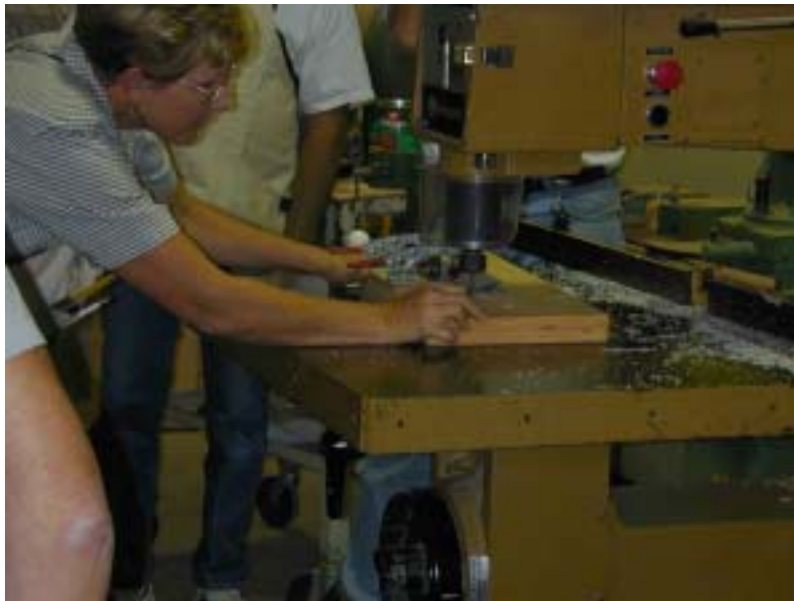
6. Initial production was started on the dust collection fitting for the back of the fence. It was decided not to drill out the hole for the hose as each person may have a different type or size. The jig from the last class was used with the pin router to cut each piece to shape. They will be formed using heat at a latter class. See photo below.

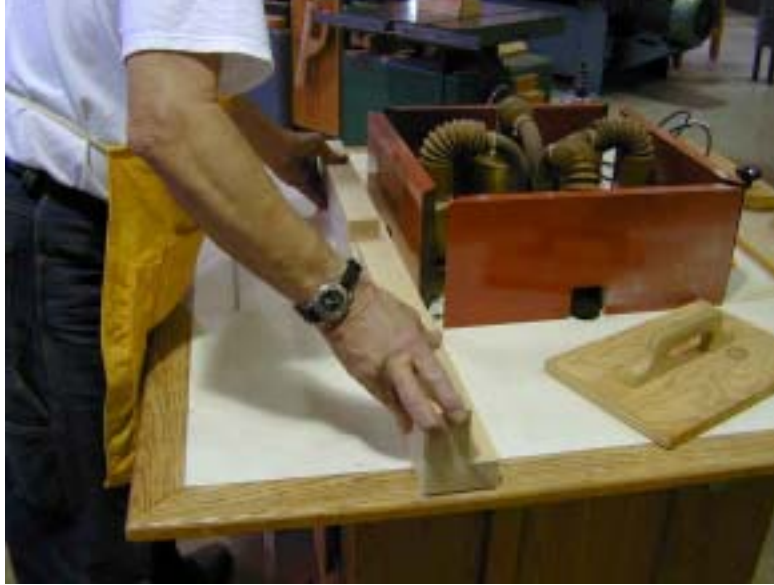
1. After considerable discussion about what to chamfer on the fence the following was completed on all 33 fences – all edges of the sliding fence were chamfered except for the edge that is cut at 45 degrees. For the main fence all top and end edges were chamfered except for edges that sit on the top. See photo below:

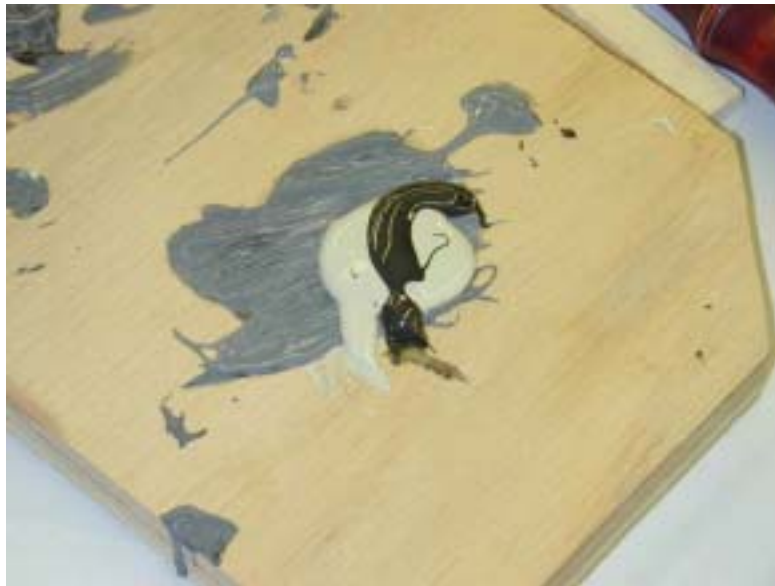
2. The all thread pieces were then inserted into the sliding fences – used JB Weld to attach. A small dab was used on the threads to lock in place. The photo below shows the material before mixing:

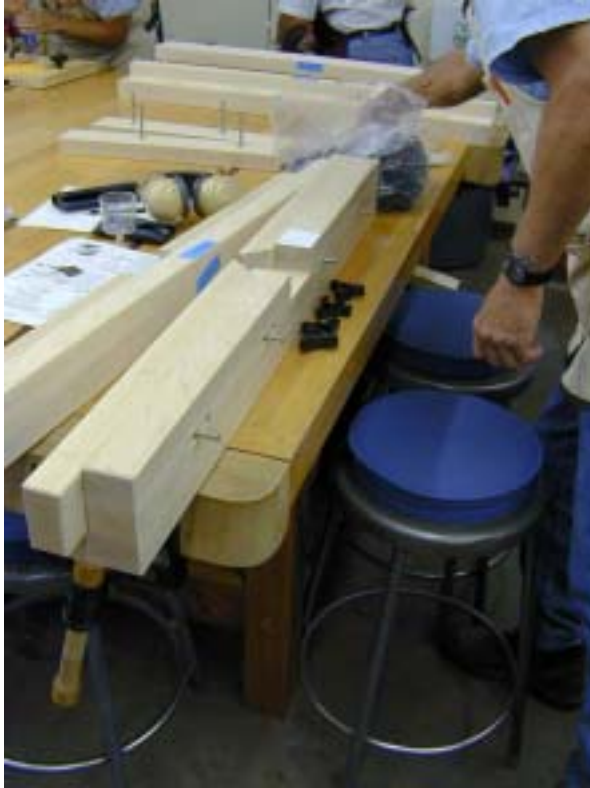
3. The sliding fences were then attached to the main fence. See photo below:

The next step was to cut an approximate $\frac{1}{2}$ inch deep dado in the top front edge. Next time it is planned to use a router bit to finish cutting the T-slot. The 33 fences were carefully checked – several sliding fences have defects and will require rework next time. Several fences have already been repaired and will be shorter than the standard 41 inch length.

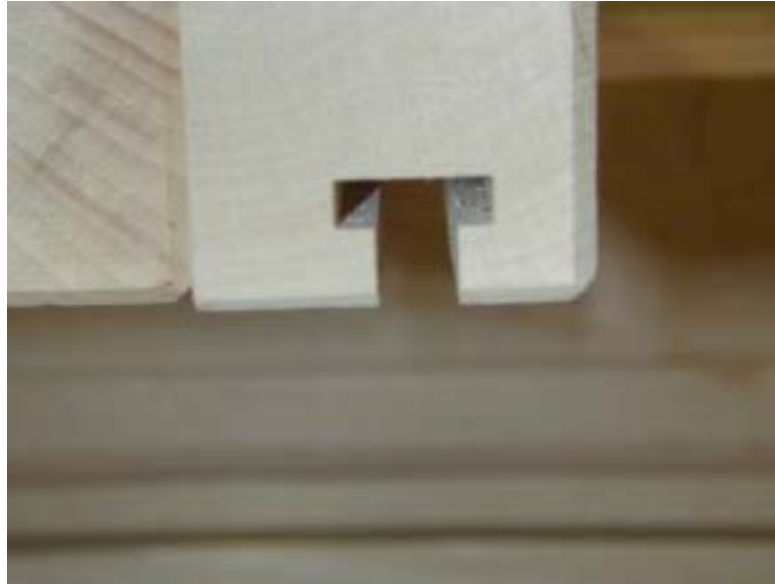
1. The clamps were finished and drilling should start next week. Also, lumber was milled for two stop blocks for each fence.
2. The t-slots were finished for all fences. This process requires patience, as the slot must be cut in one pass. Several techniques were used – normal left to right with lots of stops and backing up to clear slot and a brief reverse cut followed by a normal cut.

The photo shows the final slot. While not visible in the photo the bit is set up to leave a slight depression in the top of the slot – this is to help with the cutting process.

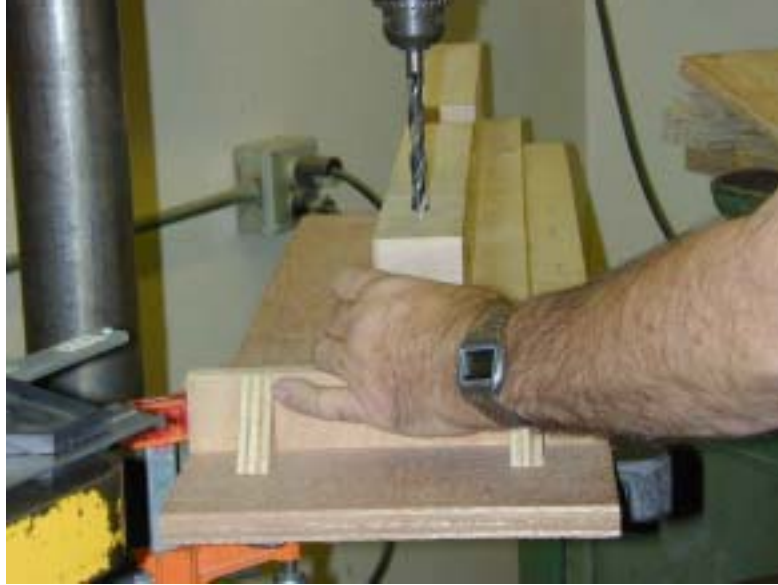
3. Of the 33 fences six needed repairs, mainly to the sliding fences. These repairs were done by drilling a hole for a small dowel and then inserting glue in the crack. The dowel was then inserted and the piece clamped to close the crack. Also, because of repairs three fences are one inch short.
4. The fences were now drilled for the clamps. This is a very slow process as the available drill bit was bad and the substitute was not long enough to go all the way through the fence. Only two holes were drilled on one end of each fence. And the hole through the fence was not completed. A longer drill bit will be used next to complete this phase of the project – need at least 6 inch 13/32 drill bit as the bolt is 3/8 inch. A jig was used to control the drilling process, see photo below.

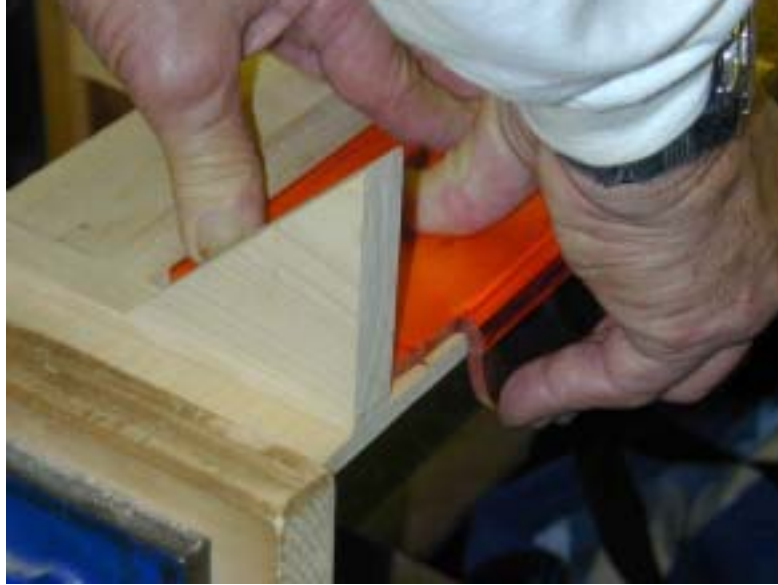
5. Two pieces of plastic are required for each fence – the dust control fitting on the back and a safety cover on the front. The school bending heater was used to bend these pieces. The first step is heat the joint both top and bottom followed by the use of a simple bending jig. The two following photos illustrate the process. The plastic must be held as it cools to insure it maintains the desired shape.

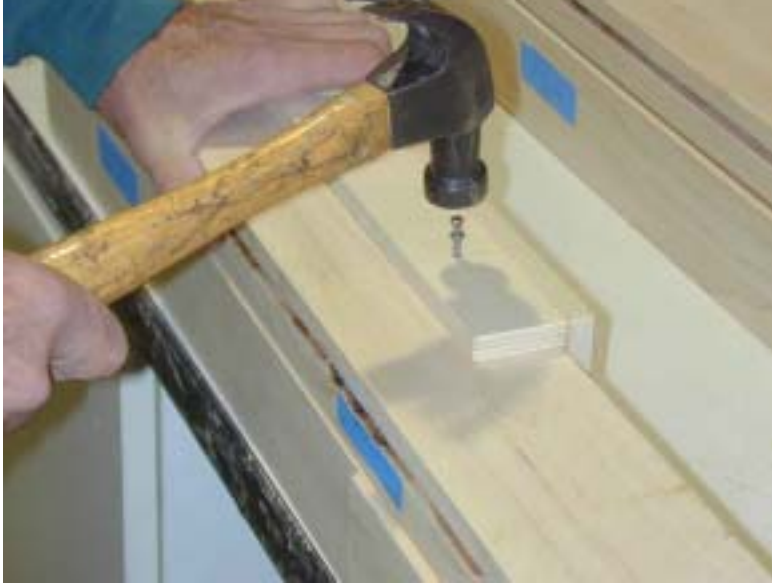
4. To plan for the pin routing attachment to be made next semester a hole was drilled in each fence for an insert. The next photo shows the jig made to locate this hole. A stop positions the jig and hitting the pin put a mark in the fence top. The inserts will be installed next class.

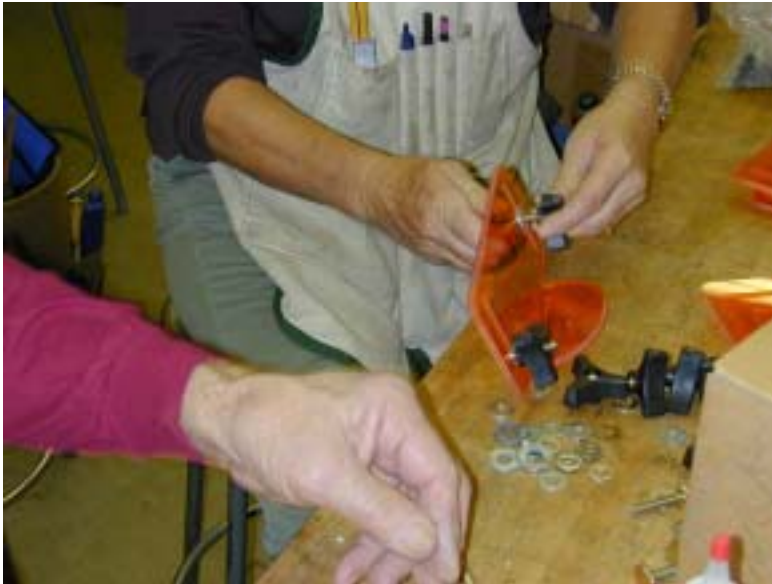
5. The bit guard hardware was assembled for each fence. It uses the t-slot for attachment. The t bolts had to be cut down by about an inch. See following photo.

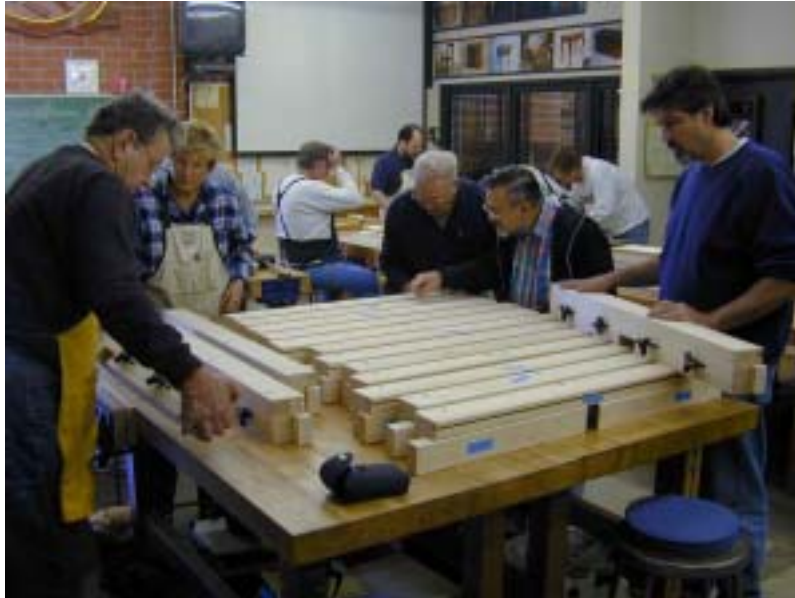
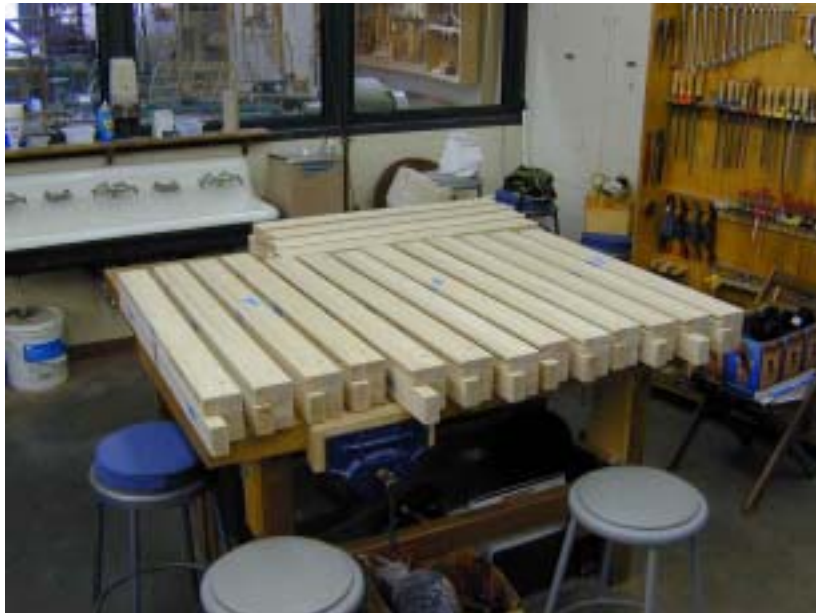
After the morning lecture the team had a brief meeting to plan the days work. The fences were all moved in the lecture room tables for final detailing. The first two photos show all the fences.

The detailing process involved several steps. First the tops were sanded on the large belt sander to remove all saw marks. Next all the paper markers were removed. While these were very helpful in keeping the front tops together with the sliding fence, they were hard to remove. We used a chisel and scrapers to remove. Next, the last remaining insert was installed manually in the top of each fence. The next step was to remove all pencil marks

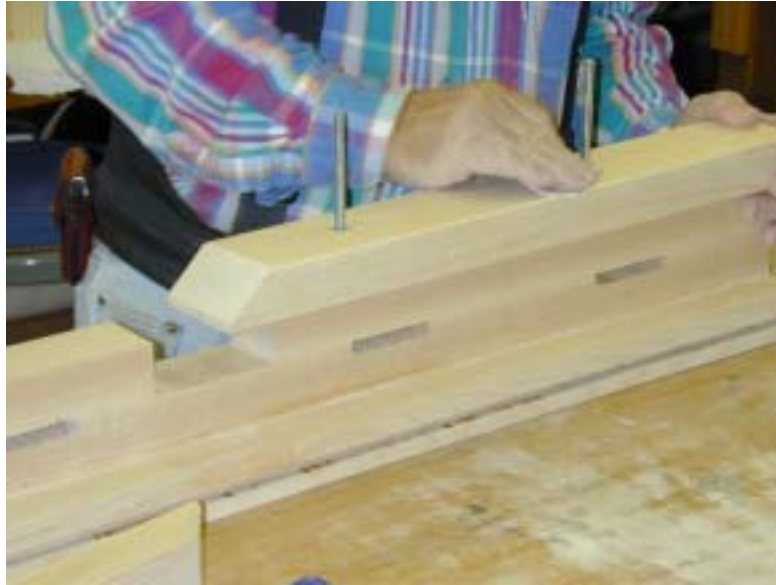
and do detail sanding (120 grit) for each fence along with quality control. One fence was found where the t-slot was not completed. Each fence owner will have to do more sanding before a finished is applied. See the next photo:

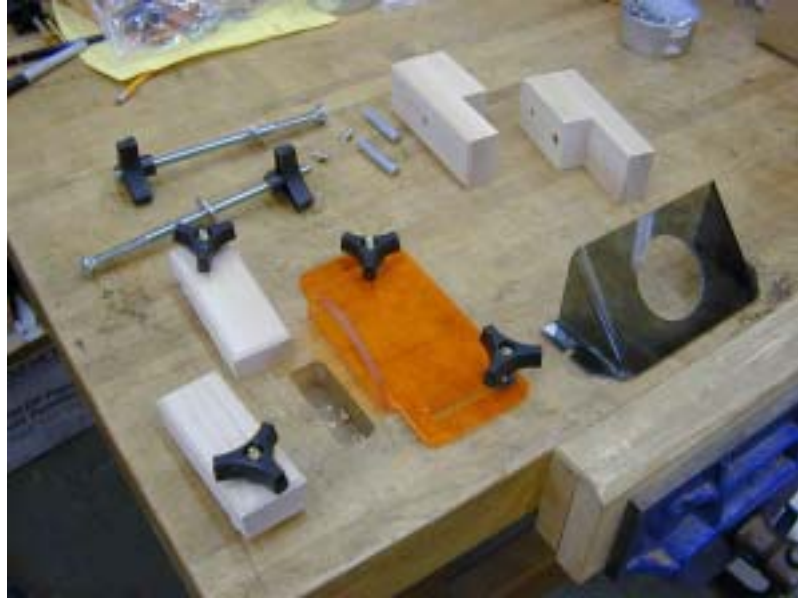
1. Two stop blocks with 2 t-bolts, 2 washers and 2 knobs (located lower left hand corner of photo – slide in t-slot and are used control the stock movement)
2. Two clamps with 2 carriage bolts, 2 fender washers, 2 knobs and 2 locator pins (these are across the top of the photo and are used to attach the fence to the router table top)
3. One safety shield with 2 t-bolts, 2 washers and 2 knobs (orange plastic in center of photo – used to cover top of bit for safety. Slides in the t-slot)
4. One dust collection port with 2 screws and 2 washers (located in lower right hand corner of photo – installed on the back of the fence for dust collection)

The total contents of the bag are displayed in the next picture:
